© D. Jensen 2006	REPLACEMENT OF XK8 CONVERTIBLE REAR WINDOW REGULATOR	V. 1.0 September 2006
Distribution: www.jag-lovers.com

While raising the top on my '01 XK8 convertible recently, I heard a loud "pop" from the right-rear seat area and saw that the rear quarter window was no longer operating. I could hear the drive motor cycle down and stop, and then cycle up and stop as I toggled the "Roof" switch. I also heard the sound of a cable flopping around.

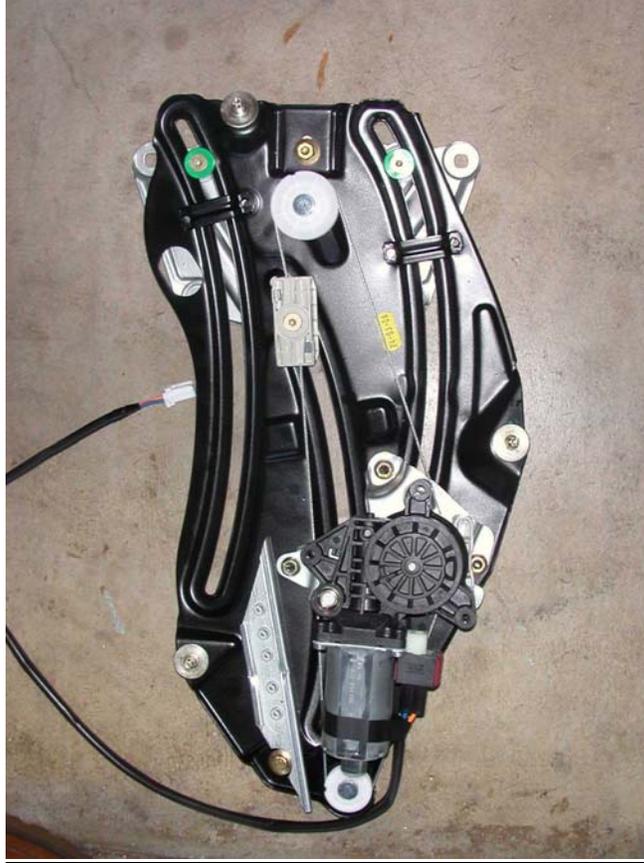
Fig. 1 New window regulator

While I probably could have repaired the regulator given enough time and a good machine shop, I wanted to get the car back on the road as soon as possible. I also didn't want to repeat this repair if my fix failed at a later date. Thus I opted to buy the replacement regulator for \$294 (before tax) (see Fig. 1). This unit did not include new glass or seals, which I didn't need. Jaguar apparently no longer sells just the regulator alone so the cost of a replacement unit with glass and seals can be expected to be significantly more.

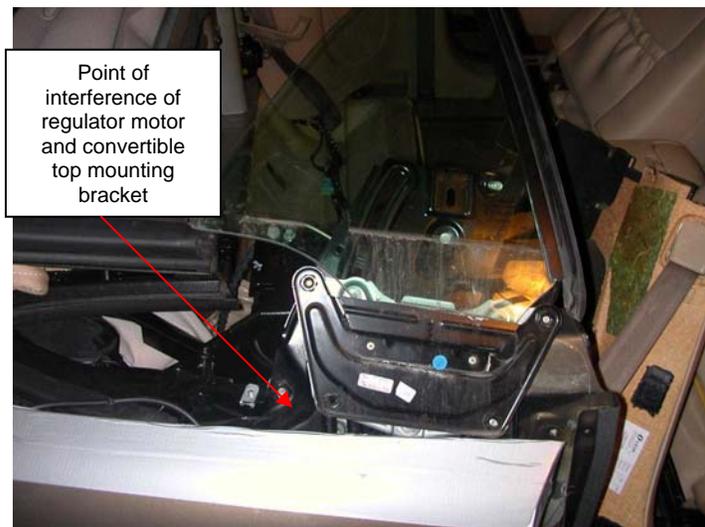
Fig. 19 Window/regulator partially removed

14. Remove the upper and middle nuts holding the regulator in place and undo the lower nut (it will remain in place because the attached washer is held to the body by silicone sealer) (Sec. 86.25.11, Steps 12 and 13) (see Fig. 12 above). Route the feed link and multiplug connector through the water shedder. Once loose, push the regulator outward to free the adjustment bolts from their holes. As I inferred from the Jag instructions re removal of the top, I could not remove the window/regulator due to interference between the regulator motor and the convertible top bracket (see Fig. 19).

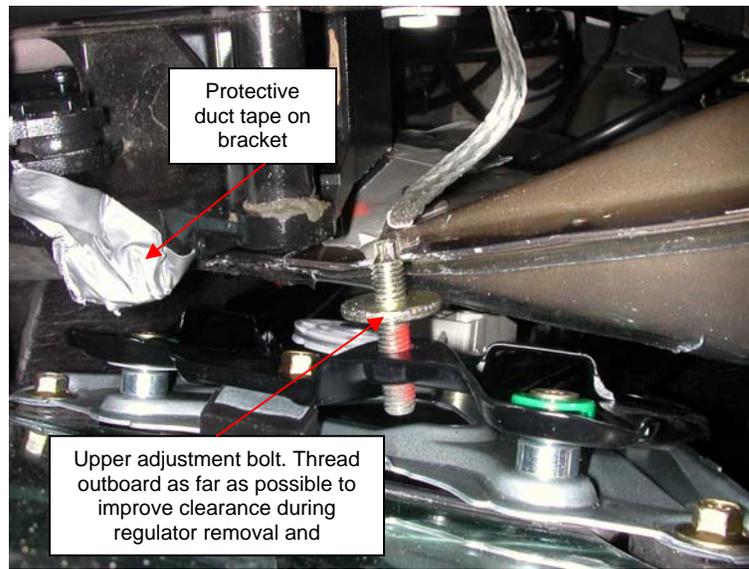
Fig. 20 Close up of upper adjuster bolt

15. Thread the upper adjuster bolt fully outboard (see Fig. 19). This eases removal in the regulator in the limited space available. The small piece of protective duct tape in Fig. 20 sits on the protruding portion of the convertible top bracket that causes the interference if the bracket is not first loosened and pushed inward.

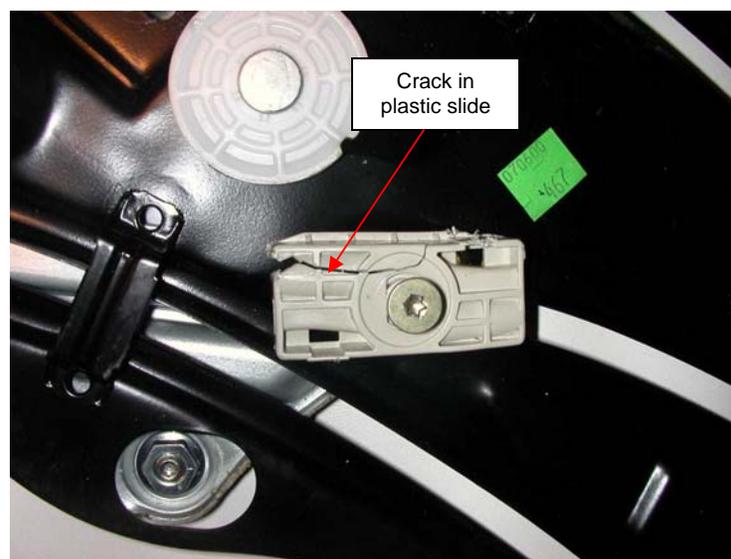
Fig. 21 Failed plastic slide

16. The next step is the real time saver. Remove the three bolts holding the convertible top bracket in place. Then push the bracket inward enough to provide clearance for the window/regulator assembly. As you might imagine, I breathed a large sigh of relief when the assembly came up and out.
17. Upon examination, the cause of the failure was evident (see Fig. 21). The plastic slide that secures both ends of the drive cable had split, allowing one end of the cable to come free (accounting for the loud "pop" since the cable is very tightly wound) and preventing further movement. Note that the slide is of two-piece construction plus pivot (not evident in the photo) and has fairly complex internal features that could be replicated, but not easily.

18. Remove the two bolts securing the glass to the old regulator (if the glass is not included as part of the new unit) and attach it to the new unit.
19. Reinstall the window/regulator in the reverse manner of removal, with one added step, adjustment of the window stop (see below). Positioning the adjusting bolts in their holes on the body proved easier than I thought. Position the regulator in the approximately correct location and then locate the bottom adjuster in the nut/washer attached to the body. Thread the other two nuts of the adjustment bolts. Adjust the unit as described in Sec. 86.25.11, Steps 10 – 22. This adjustment took me about 30 minutes of fiddling to get it right.

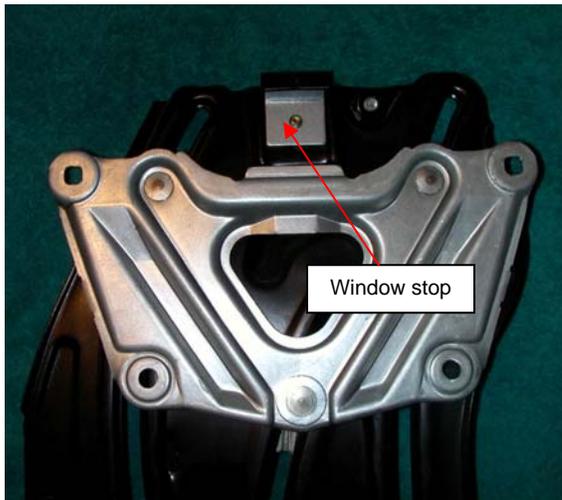
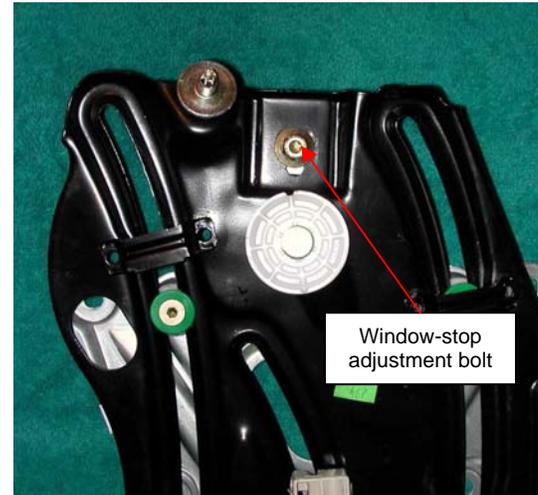
Figs. 22a and 22b View of window stop and adjustment bolt

20. One item not mentioned in the manual and that I overlooked at first was adjustment of the window stop on the new regulator (see Figs. 22a and 22b). As received, the stop on the new regulator did not allow the window to rise to a fully closed position in the convertible top rubber seal, leading to wind noise and water leaks. A check of my failed regulator showed the stop had been at its uppermost position, whereas the new unit was at its midpoint. As expected, making this adjustment addressed both the wind noise and water ingress issues.
