© D. Jensen 2005	REPAIR OF RADIO ANTENNA ON '01 XK8 AND XJ6/XJ8s USING SIMILAR HARADA ANTENNAS*	V. 1.0 Dec. 5, 2005
Distribution: www.jag-lovers.com CC: X300/XK8 List Administrators

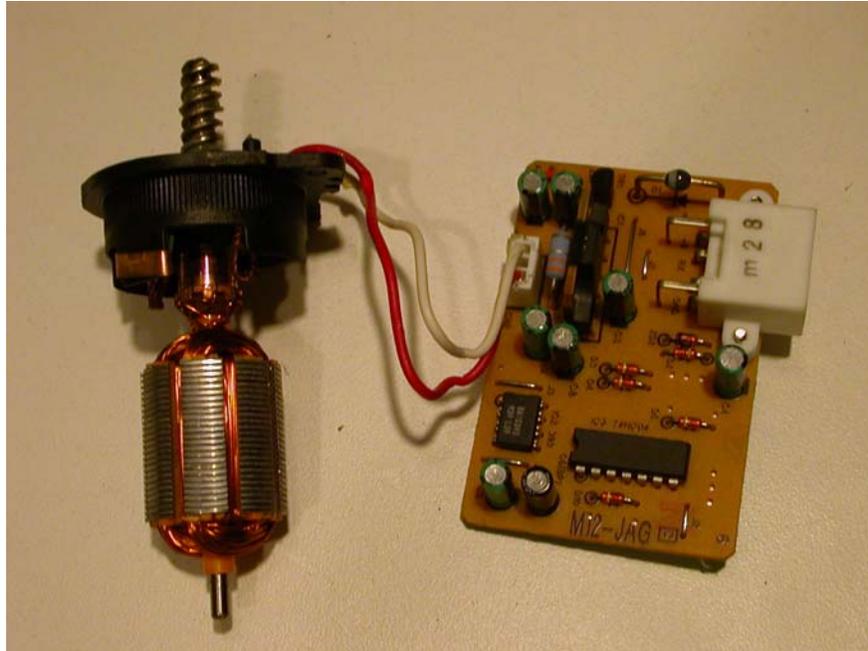
Fig. 9

9. Pull the armature and brush assembly from the motor housing (Fig. 9). A good pull is required due to the magnetic fields tending to hold the armature in place. There are no screws or other means of attachment. Note the number on the circuit board, "M12-JAG", perhaps indicating a Jaguar-specific design.

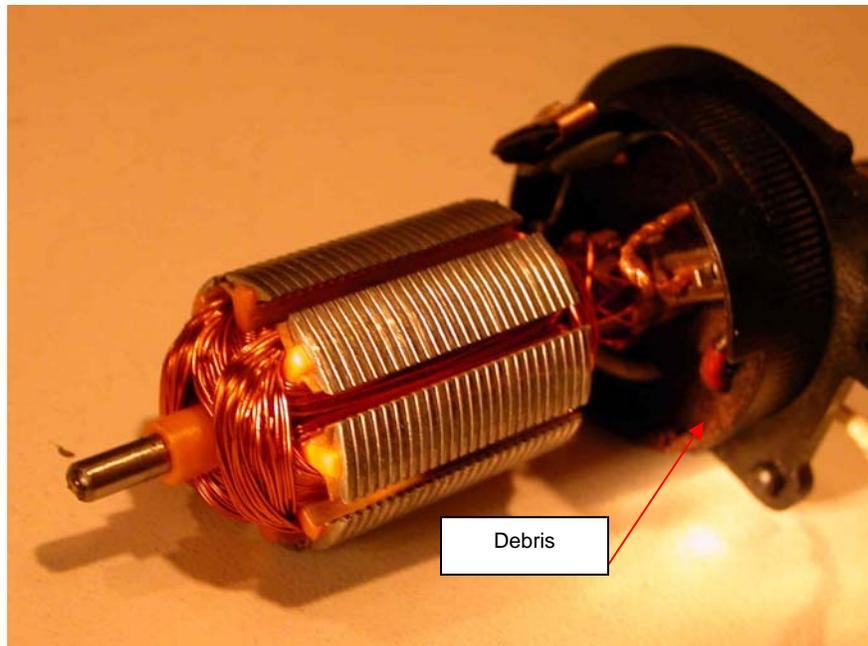
Fig. 10

10. Look closely at the motor windings, brushes, etc. Mine had copper and carbon debris near the brushes and on the black-plastic end piece. I suspected these might be the source of the intermittent operation (Fig. 10). Everything else looked pristine. There were no adjustable components on the circuit board.

11. Clean the commutator, gaps in the commutator, brushes and surrounding area with Q-tips and electrical spray cleaner. I gently pulled an X-Acto blade through the gaps in the commutator to remove residual debris there as well. Figure 11 shows these items during cleaning.
