**Technical Guide**

**XJS HOOD  
SEALING  
TECHNIQUES**

# XJS HOOD SEALING TECHNIQUES

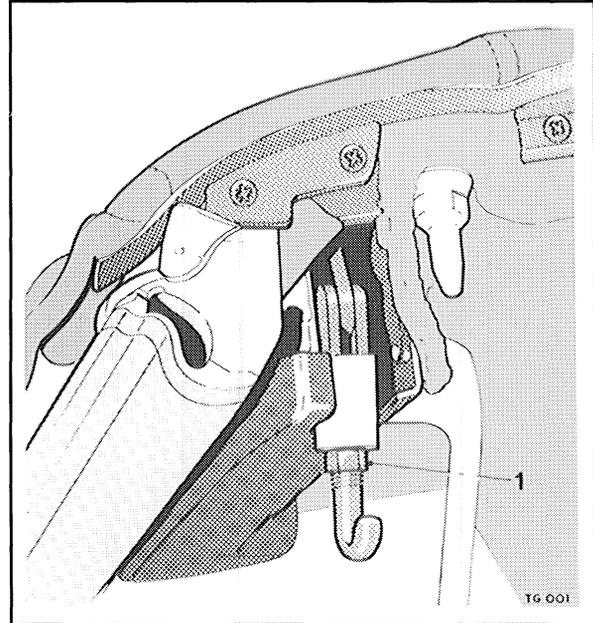
Fig 4.1

Leaks in the vicinity of the 'A' post or the adjacent front hood seals are often caused by incorrect hood locking tension. Too much or too little tension can create leak paths.

Open the hood and check for obvious defects such as seal collapse or damage. If the seals are acceptable, close the hood and operate the locking handles to check the tension. If the lock is difficult to operate, the hood is probably over-tensioned. Release the retaining locknut (1 Fig 4.1) and unscrew the hook one full turn.

The reverse procedure is used if the hood is found to be slack. Increase tension by screwing in the hook one full turn at a time until optimum tension is achieved.

Test the car and repeat the operation as necessary.

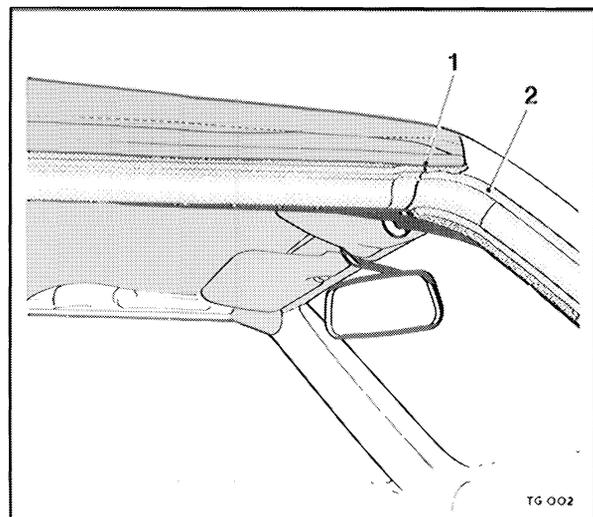
Fig.4.2

If a leak is evident between the 'A' post to hood front seal (1 Fig 4.2), the corrective action is as follows:

Separate the glued joint of the 'A' post seal to the door lower seal.

Remove the 'A' post seal (2 Fig 4.2) from its carrier.

Remove the seal carrier from the 'A' post and clean both the post and the carrier.

Apply strips of adhesive foam strip down both outer edges of the seal carrier ensuring that the screw holes are unobstructed.

Apply a second thickness of the foam to the top three inches (75 mm) of both sides of the carrier. This ensures that the carrier will pull up squarely and evenly when it is refitted

Refit the seal carrier ensuring that it is at its outermost position thereby exerting maximum pressure on the door glass, yet permitting adjustment if the glass is subject to too much pressure.

Discard the old 'A' post seal and replace it with the new type which is identified by its 'flock' sprayed finish.

Apply Permabond C2 adhesive to the joint between the 'A' post seal and the door lower seal.

Note: Ensure that the abutment ends of the seals are mated correctly around the joint adjacent to the glass (see Fig 4.2).

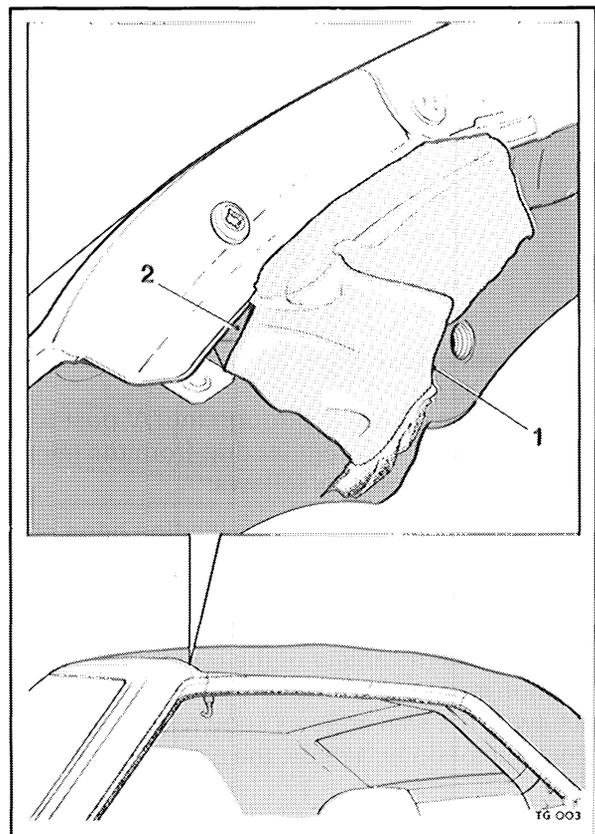
Fig.4.3

If a leak is evident between the door opening draught excluder and the 'A' post seal, it is likely that the header rail channel is the source of the leak. Proceed as follows:

Remove all traces of sealant from the header seal retainer/carrier. This channel is designed for drainage and must not be obstructed.

Apply Butyl tape (1 Fig. 4.3) to the perimeter of the header rail. Note that it is essential that a small drainage gap (2 Fig. 4.3) is left at the end of the header rail channel. This ensures that any water in the channel will be directed to the outside of the car.

Refit the header rail seal, using a rivet.

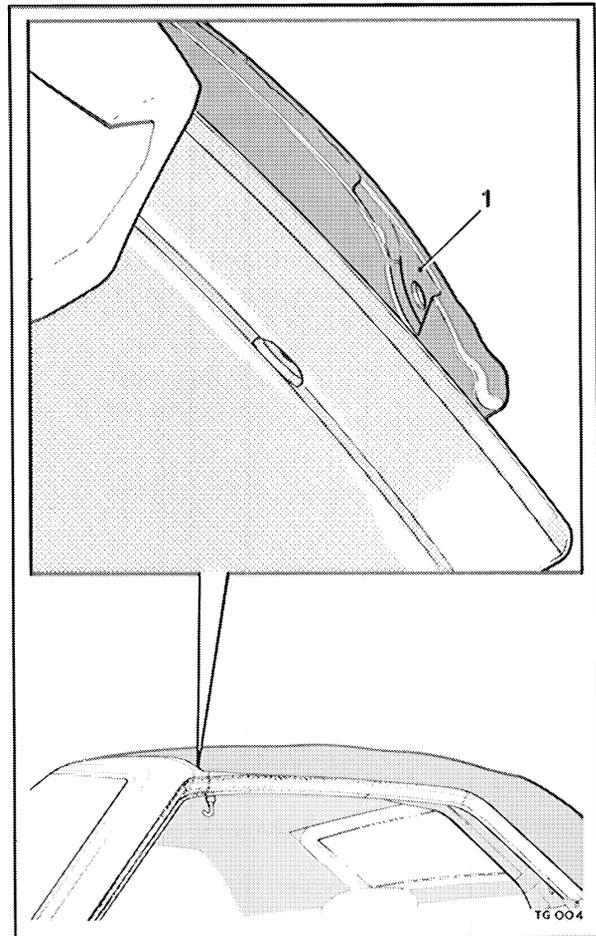
Fig 4.4

Under certain circumstances a leak may be found in the vicinity of the 'A' post lower trim pad. This will probably be emanating from a small hole between the inner and outer skins at the top of the header rail. In this case, proceed as follows:

Remove the header seal retaining rivet.  
Remove the seal from its carrier to permit access to the end of the channel.  
Add sealant to the notch area (1 Fig. 4.4) of the header rail to create a water-tight condition.  
Replace the header seal and secure with a rivet.  
Retest the car.

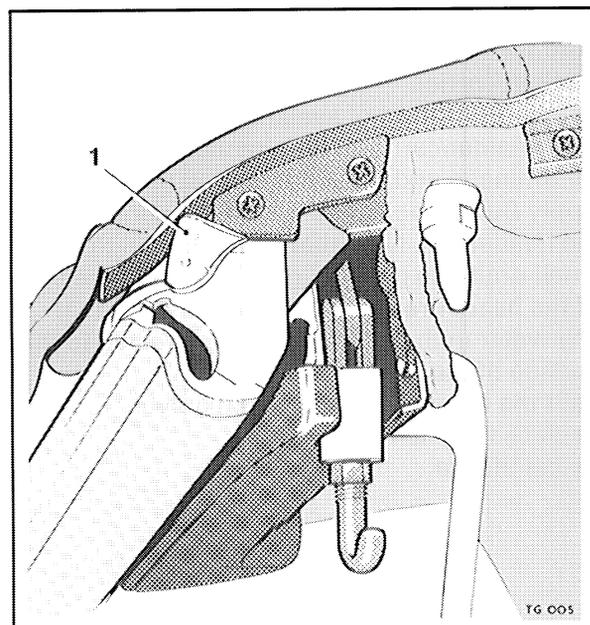
Fig 4.5

Should there be a leak through the 'A' post side hood seal, or a regular drip from the latch block hook, proceed as follows:

The flip seal (1 Fig. 4.5) at the leading edge of the front hood seal has a tendency to become trapped, and thereby cause a leak path. Removal of this portion of seal will not compromise the ability of the remainder to function correctly.

Cut away the seal edge as shown in Fig 4.5.  
Close the hood and retest the car.

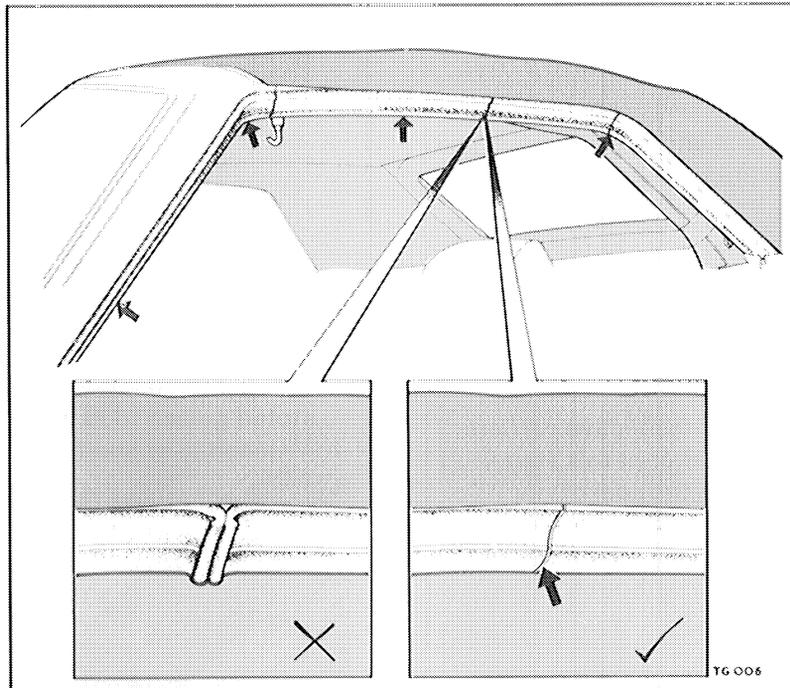
Fig. 5.1

The hood seals above the door glass must seat correctly with a small gap (2 to 3 millimetres) at their abutment ends, or they will not seal properly. Any overlap will cause 'tracking' of water through the seal. It is preferable for the seal to have a visible gap, even to the extent that daylight can be seen through it from inside the car, than for the seal ends to touch.

Fig 5.1 shows incorrect and correct conditions.

If the seal-end conditions are incorrect, the positions of the seals will have to be adjusted to compensate. Push the centre seal and rear seal along their seal carriers so that the correct gap is achieved between them, but without affecting the small overlap that is required at the outer area of the 'A' post/front seal joint (Sub-section 4.2 and Fig 4.2 refer).

When the correct gaps are achieved, (ensuring that the seals are not crushed together in the area of the 'D' glass), retest the car and make any further adjustments as necessary.

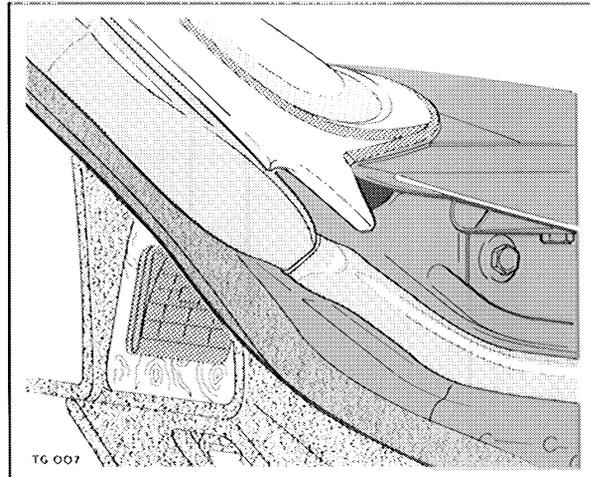
Fig 6.1

Check whether or not a leak is evident between the 'A' post/door post seal and the body sheet metal (see Fig. 6.1 where the potential leak path is indicated by arrow 'A'). If there is, proceed as follows:

Examine the glued joint between the 'A' post seal and the door seal (1 Fig 6.1). This joint must be completely watertight. If unsatisfactory, proceed as follows:

Separate the joint. (Slight damage to the seal ends is acceptable as there should be sufficient length of seal left to permit them to be worked along their carriers to reconnect them).

Reconnect the seal ends using Permabond C2 or Loctite 424.

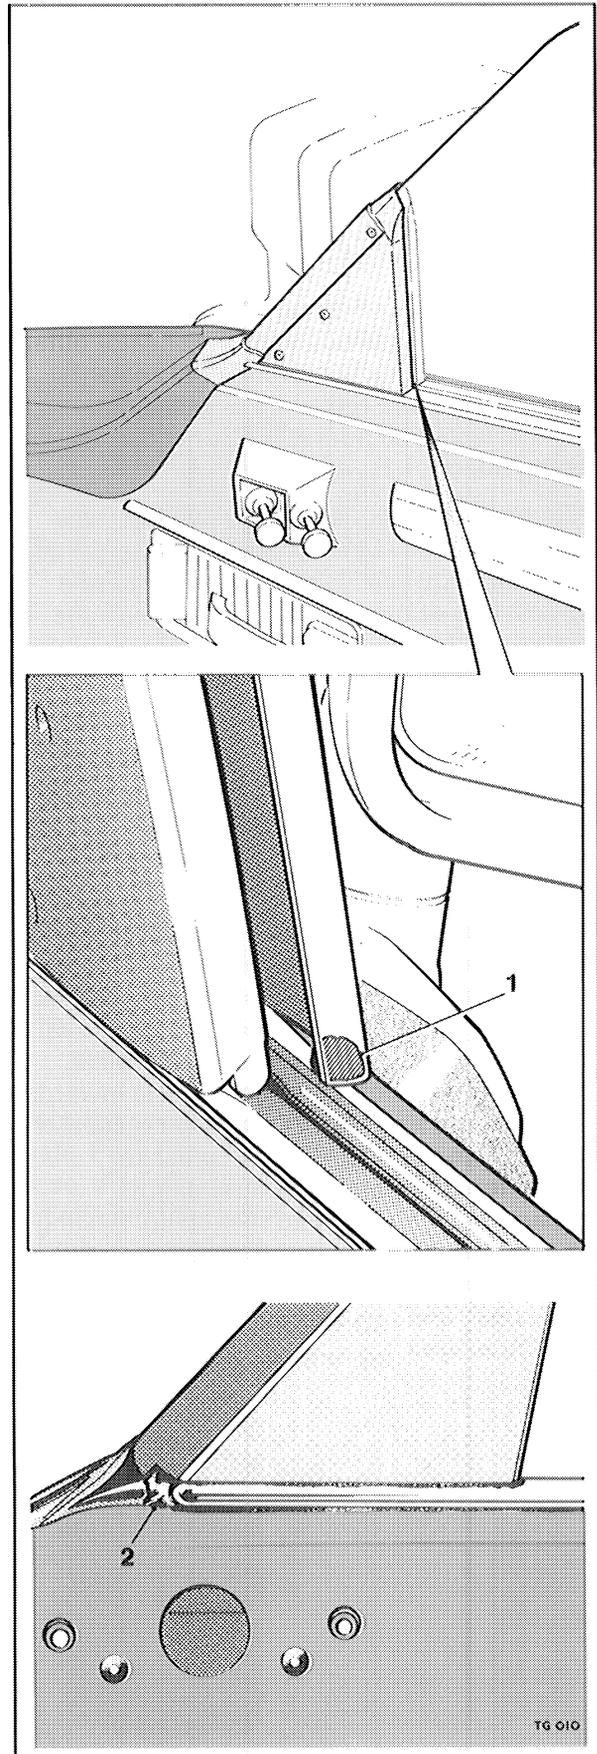
Fig 6.4

It is possible that the leak is emanating from the cheater plate base or the cheater plate front seal. If a leak is suspected here, it is advisable to remove the door casing before commencing with the following actions:

Remove the screws which secure the cheater outer cover, and draw the cover outwards. Run a bead of sealant (1 Fig 6.4) between the chromium plated finisher and the cheater support brackets. Refit the outer cover. Run a bead of sealant between the chromium plated finisher and the top of the door and the cheater plate base.

Add a bead of sealant (2 Fig 6.4) to the junction of the chromium plated finisher and the rear of the cheater outer cover. This will prevent water tracking backwards behind the cheater and into the car through the 'A' post area.

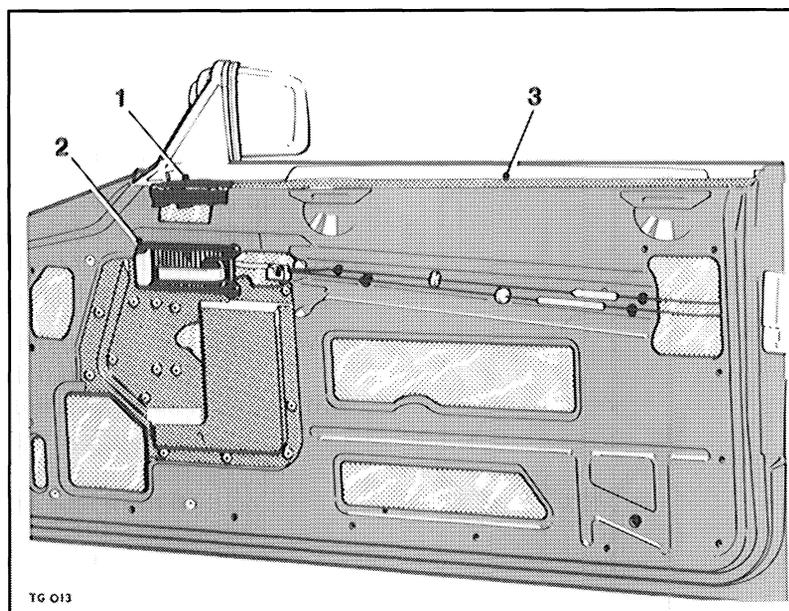
Fig 6.7

If any faults found so far have been rectified and water is still leaking on to the door casing, it is likely that the door curtain requires attention. The door is designed to carry water between its inner and outer skins so it follows that if the door curtain is damaged or incorrectly fitted, it will not fulfil its intended purpose.

Ensure that the curtain is pulled out of the aperture adjacent to the cheater plate and taped down to the door inner skin (1 Fig 6.7).

the region of the door mechanism (2 Fig 6.7). Secure the second part of the curtain to the door-top inner skin using adhesive tape (3 Fig 6.7).

Spread the remainder of the curtain out to give as much coverage as possible. When satisfied that the door curtain is fitted correctly and will perform as designed, refit the door inner casing and test the car.

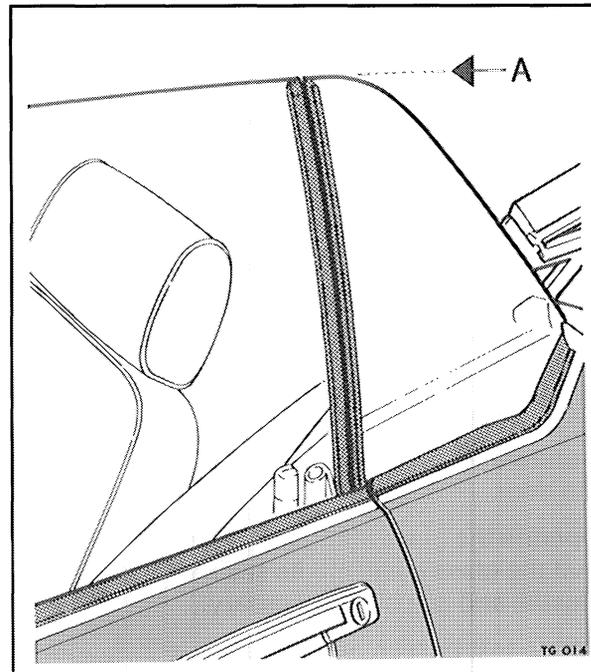
Fig 9.1

Aim for a condition where the tops of both the door glass and the 'D' light glass are at exactly the same height (as shown at arrow 'A' on Fig. 9.1).

Aim also, to finish with sufficient pressure exerted on the front, centre and rear hood seals, the 'A' post seal and the seal which runs between the rear edge of the door glass and the 'D' light. The 'flock' sprayed section of this seal (1 Fig. 9.2) must be lightly and evenly compressed along its full length. The seal must not be compressed so far that it touches the rubber inner lip (2 Fig. 9.2). The lip is not a seal, and if fouled will permit water to track across and cause a leak.

The door glass height should be set so that at its lowest position it runs level with or slightly lower than the outer waist seal rubber. At its upper level it should pass and make contact with the cantrail seals. If the glass cannot be moved higher without over-tensioning the cheater top seal, the cantrail seal carriers will need to be lowered to meet the door glass and create the necessary 'flip'.

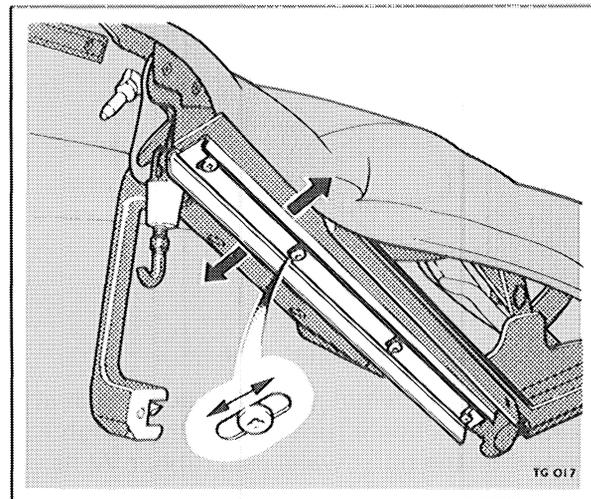
Fig 9.4

If the door glass is pushed gently inwards, the seals around the glass top and the 'A' post should simultaneously move inwards. If not, it is likely that the cantrail seal carriers are not sufficiently outboard or that the door glass is not sufficiently inboard.

Slacken the screws that retain the seal carriers and move them inwards or outwards as necessary.

Tighten the screws.

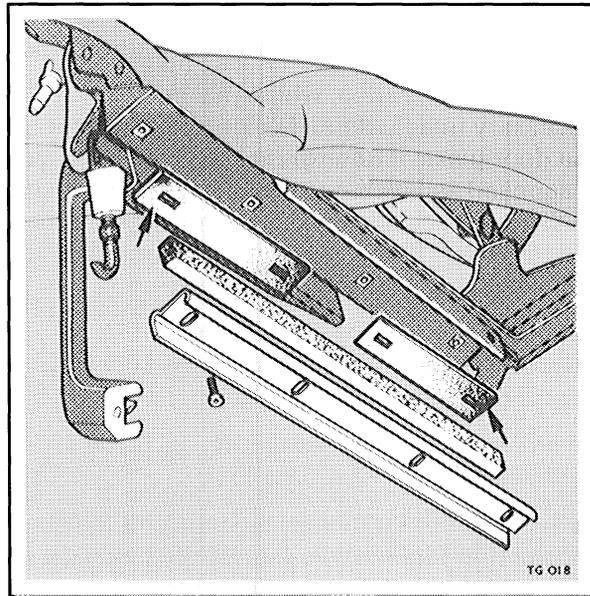
Fig 9.5

If the seal is too high (above the glass) with the glass raised to its fullest extent, it becomes necessary to pack the seal carriers downwards to bring the seals into correct contact with the glass as follows:

Slacken the screws which retain the hood seal carriers and insert a packing strip between the carrier and the seal. This will reduce the gap between the hood seal and the glass. Ensure that the carriers remain level with each other as this is critical to achieving a sealed hood whilst maintaining good hood shape.

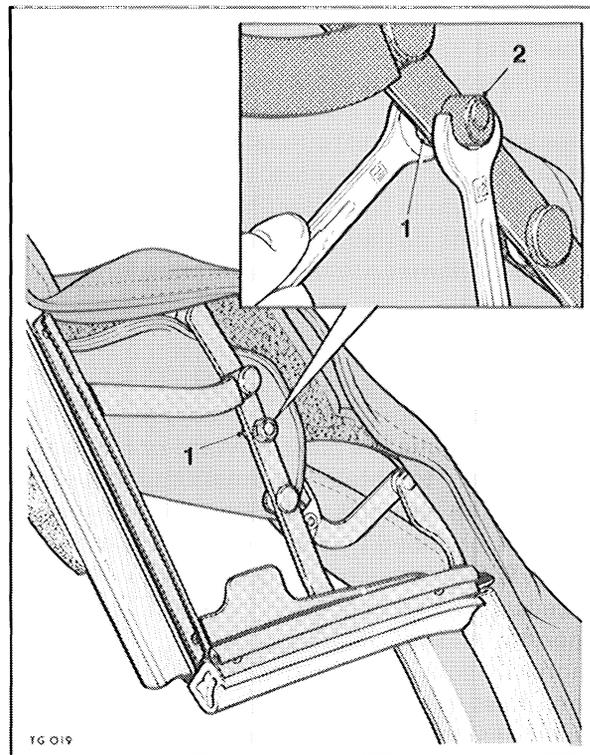
Fig 9.6

On later cars, a further hood adjustment is possible, and brings the joint of the front hood seal and the centre hood seal closer to the glass top edges. It also permits better adjustment when attempting to keep the hood seal carriers level.

Undo the 8mm securing bolt (1 Fig 9.6).

Reaching inside the hood, adjust the cam (using a 12mm open-ended spanner on the flats (2 Fig 9.6) of the cam adjuster) to obtain optimum hood seal height.

Tighten the securing bolt.

Fully close the hood. Check the seal to glass position and re-adjust if not satisfactory.

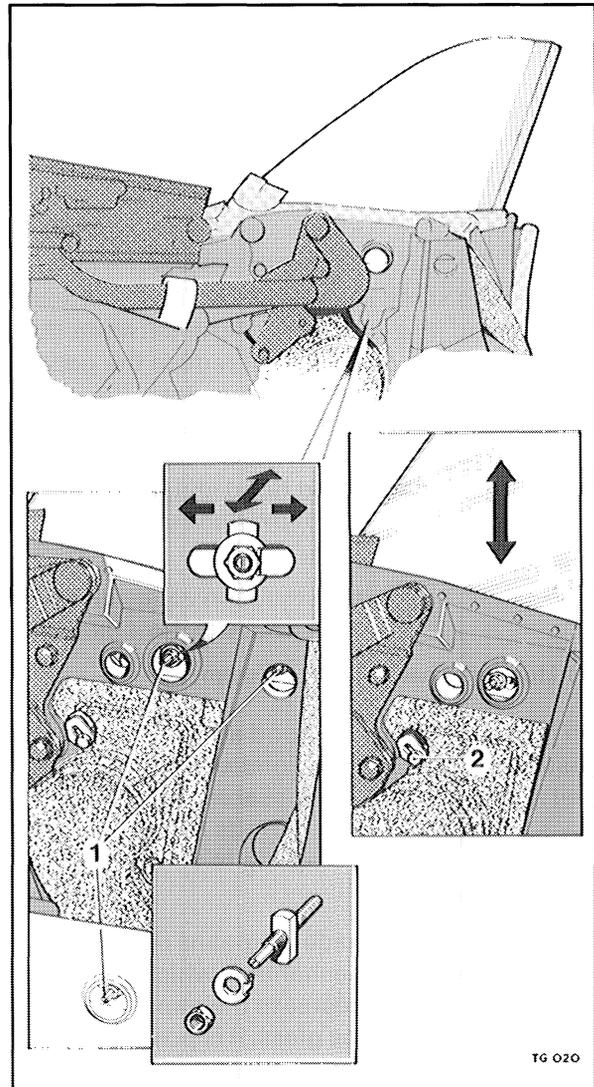
Fig 9.5

It is possible for the door glass and the 'D' light glass to overlap, which makes it necessary to adjust the 'D' light glass and/or the door glass. If door glass adjustment is diagnosed as being necessary, try to restrict it to the rear securing screws, as adjustment of the front may compromise the performance of the 'A' post and header rail seals.

Lower the 'D' light glass to approximately its halfway position, and slacken the 10mm nuts that secure the adjustment screws (1 Fig. 9.7). These screws adjust both lateral and fore and aft positioning of the glass. Remove the locking washers (this must be done to eliminate the possibility of adjustment screw or washer damage whilst attempting adjustment).

Use a 5 mm box spanner to adjust the lateral positioning of the glass, clockwise to adjust inwards and anti-clockwise to adjust outwards. Move the glass forward or rearward as necessary to obtain the optimum position and refit the washers and nuts. Optimum height is obtained by slackening the lock screw (2 Fig. 9.7) and raising or lowering the glass as necessary. Adjust the glass so that it both operates and seals correctly, and aligns correctly with the door glass and the door glass-to-'D' glass seal. Water-test the car and make any further adjustments necessary.
