TECHNICAL BULLETIN

A-Pillar or C-Pillar –
Cosmetic Paint Blemish –
Repair Care Points

MODEL 2004 MY-ON
XJ range
VIN G00001-ON

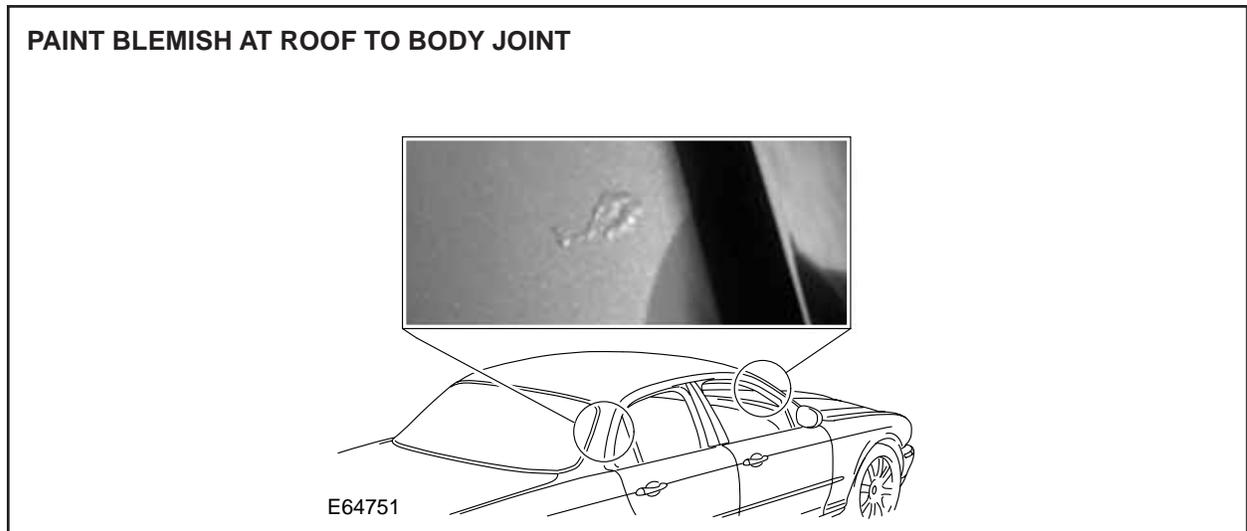
ILLUSTRATION 1

1. The following care points are applicable to the repair of localized cosmetic paint blemish (Illustration 1) in the aluminium welded roof to A-Pillar and the C-Pillar roof to rear fender joints. It is important to note that the paint blemish is purely cosmetic and will exist only between the surface of the aluminium and the paint film.

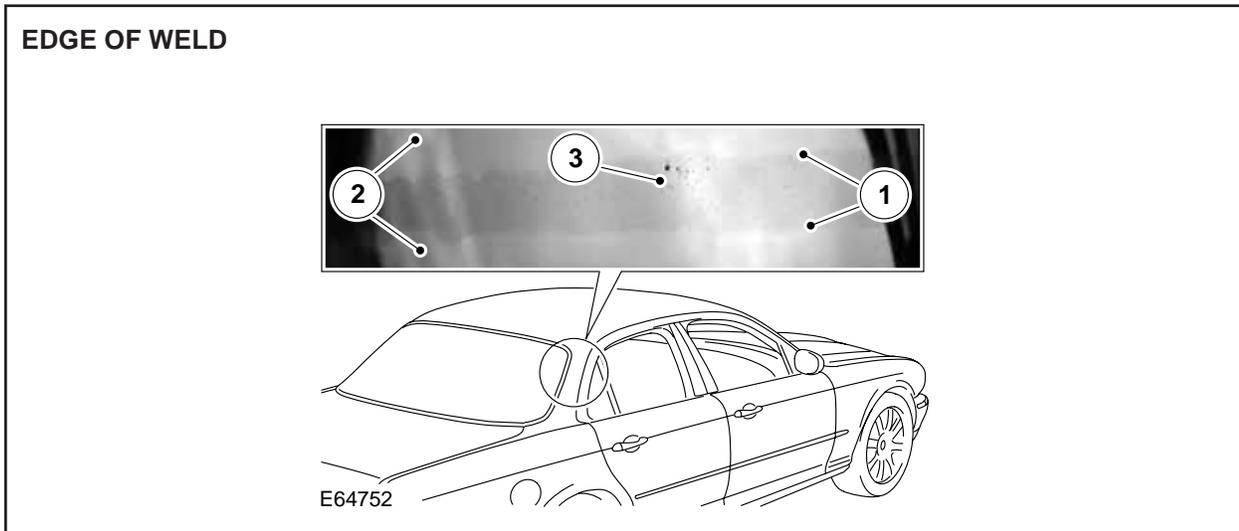
ILLUSTRATION 2

⚠ Caution: Particular care needs to be made to reduce sanding between the edge of the weld (arrowed 1 in Illustration 2) and the adjoining sheet aluminium (arrowed 2 in Illustration 2).

2. For a robust repair, the paint blemish must be completely removed prior to repainting. The following care points relate to the removal of the paint film/blemish and reworking the area:

3. Grinding/sanding in and around the roof joint needs to be minimized. It is recommended that power tools are not used. Removal should be achieved through local sanding by hand.
4. Once the paint is removed, the weld is noticeable by a slight discoloration against the sheet aluminium (arrowed 1 in Illustration 2). This is perfectly normal.
5. In some cases minor porosity (arrowed 3 in Illustration 2) may be apparent in the weld. This is normal and it is not necessary to remove the porosity by grinding/sanding.

Note: Best practice is to minimize the amount of filler applied to the joint (after applying etch prime coat) once the blemish has been removed.
