S-TYPE

S303-24

## TECHNICAL BULLETIN

V6 Engine MIL Lamp On/DTC P0332 –  
Water Entry In Knock Sensor Connector –  
Install Sealing Patch

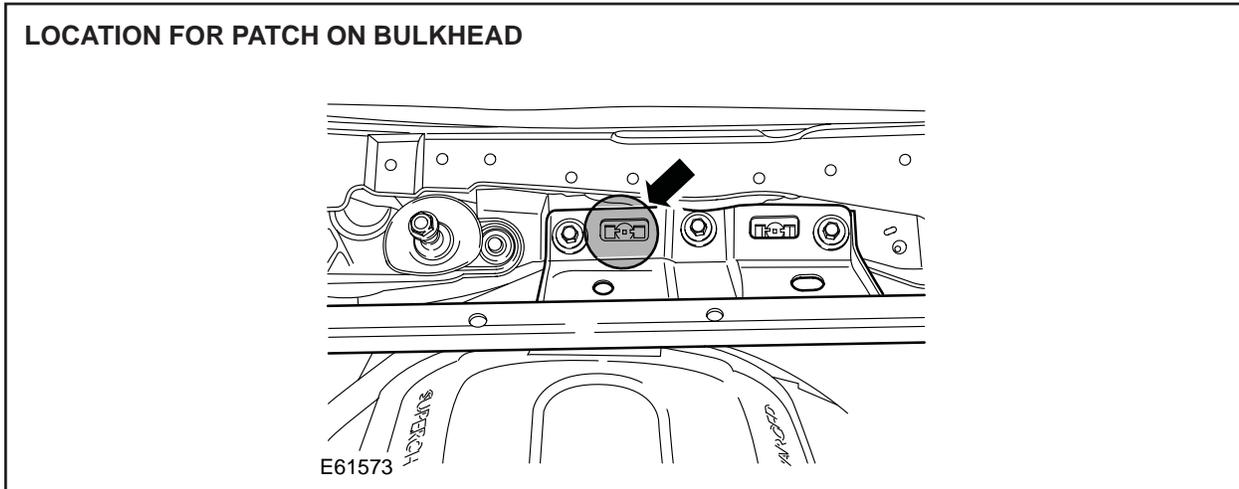
ILLUSTRATION 1

Water can run through the cowl panel fixing hole, on to the engine harness carrier and into the knock sensor.

5. Switch 'OFF' PTU, disconnect from vehicle and return WDS to original location.
6. Remove the cowl panel grille (see Global Technical Reference GTR Workshop Manual, section 501-02).
7. Clean the area on the bulkhead bracket of the suspension turret brace where the adhesive patch will be applied (Illustration 1).

8. Ensure the plastic insert is centered in the rectangular hole of the brace.
9. Remove and discard the backing from the adhesive patch and install the patch centered over right-hand rectangular hole furthest to the rear the brace (see illustration 1).
10. Install the cowl panel grille (see Global Technical Reference GTR Workshop Manual, section 501-02).
11. Remove the **left-hand** (upper) knock sensor (see Global Technical Reference GTR Workshop Manual, section 303-14A, SRO 18.30.92).
12. Remove the engine harness electrical connector for the knock sensor from the mounting, and position it downwards to ensure no water is present in the PVC tube that covers the harness.
