4-3 Pre-Stroke Valve Spring

56947J-S1

Sonnax Part Summary

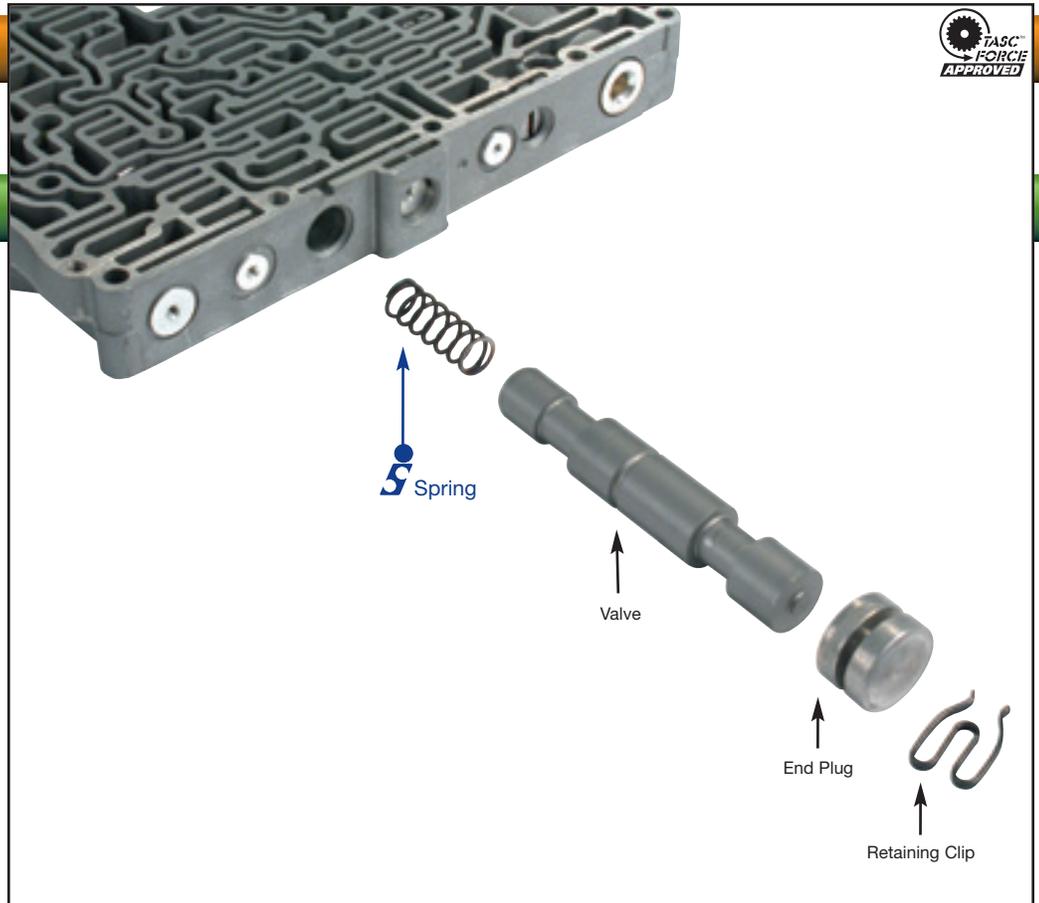
No 4th or 5th gear

Breakage of the 4-3 pre-stroke valve spring prevents proper valve function.

Complaints of no 4th or 5th gear, codes 734 and/or 735, and solenoid C codes can occur on the 5R55N due to a broken 4-3 pre-stroke valve spring. The 4-3 pre-stroke valve controls the apply and release rate of the intermediate servo and direct clutch, which should be applied in 4th and 5th gear. The Sonnax 4-3 Pre-Stroke Valve Spring **56947J-S1** addresses these complaints. This spring is not used on 5R55W & S units.

Replace with the reduced-stress Sonnax spring.
