**Wind Noise –
Check Door Mirror Gaps –
Repair Procedure**MODEL 2000 MY-ON
S-TYPE

VIN L00001-ON

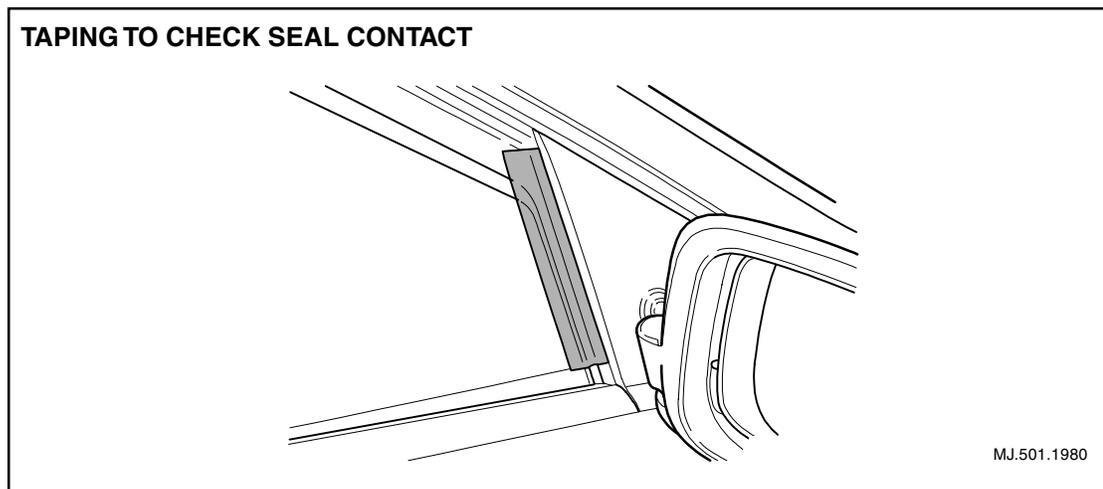
ILLUSTRATION 1

WEAK GLASS SEAL CONTACT – FRONT DOOR

1. Attach a piece of tape across the glass seal and side glass. (Illustration 1).

Note: The tape should follow the contours of the seal so as not to change the shape.

2. Test drive the vehicle and evaluate. If there is no longer a noise coming from the seal, a new glass seal is required.

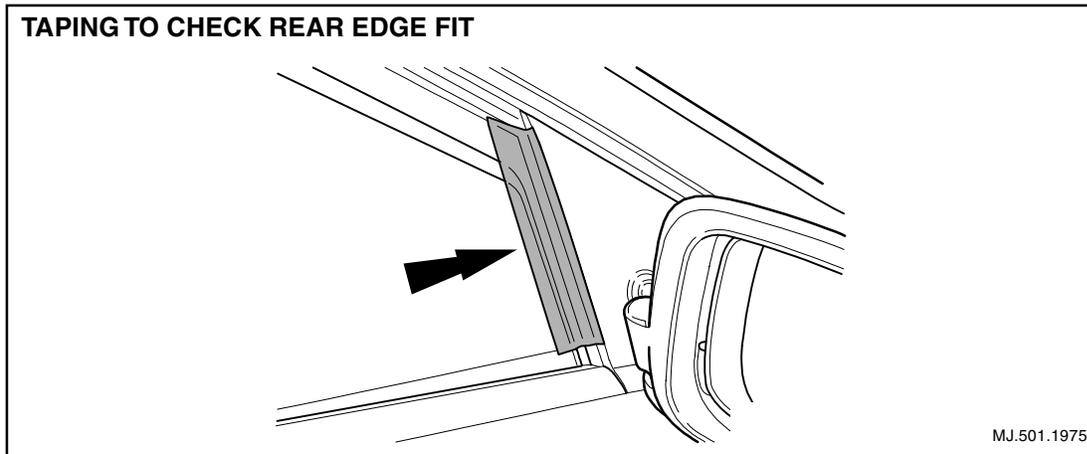
ILLUSTRATION 2

This particular wind noise can be identified by applying tape across the rear edge of the mirror base to the side glass. The tape should follow the contour of the parts so as not to change the form.

1. Fully tape the rear edge of the mirror base (Illustration 2)

2. Test drive the vehicle and evaluate. If the noise is eliminated investigate further and continue with the procedure below.

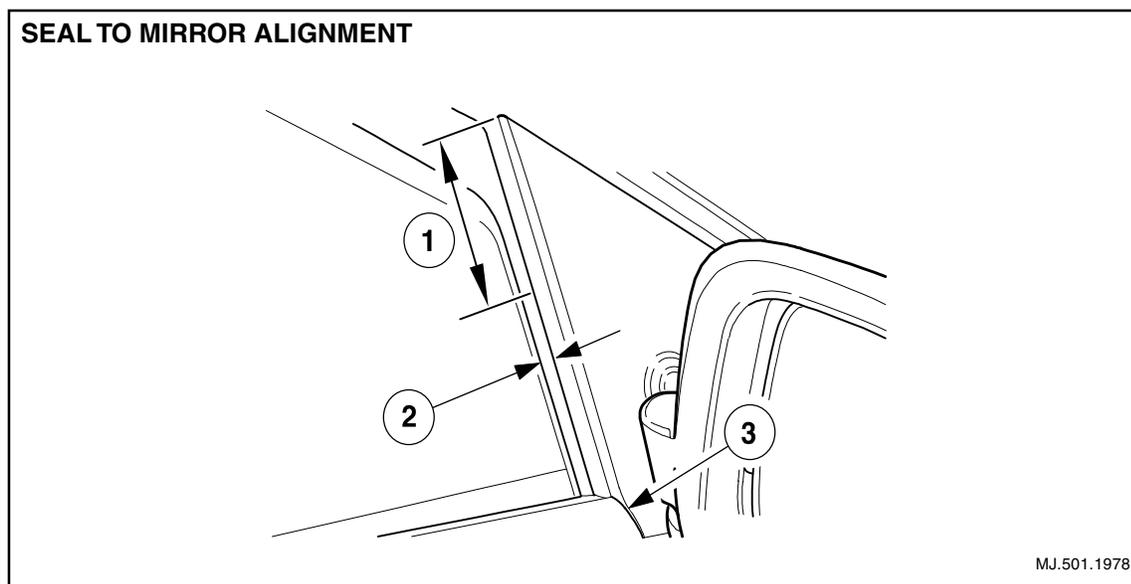
ILLUSTRATION 3

The rear edge of the mirror base should fit approximately 0.5 mm away from the glass seal along the 50 mm length (1, **Illustration 3**). The thickness of visible glass seal along the rear edge should be approximately 4-5 mm wide (2). The mirror base should sit evenly on top of the waist finisher along the length of the flip seal (3).

If not, follow the procedures below:

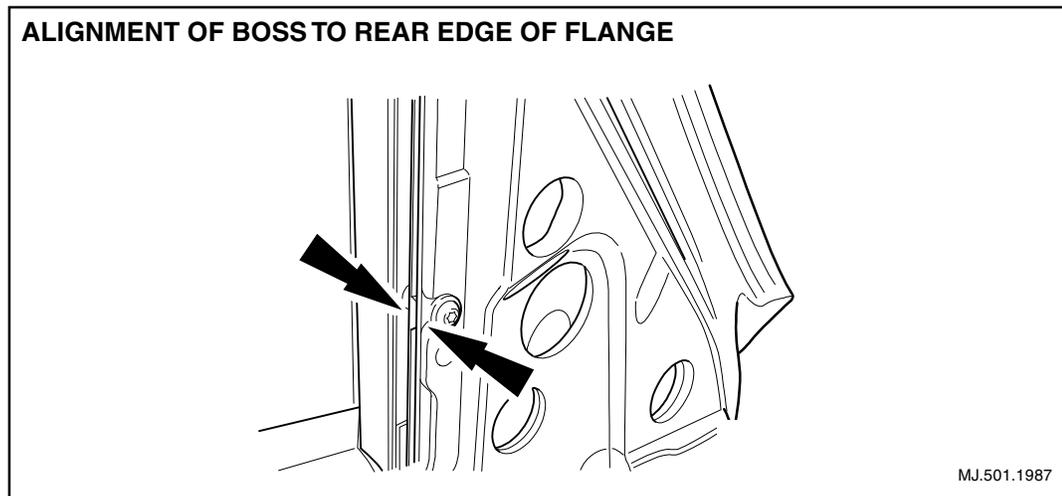
ILLUSTRATION 5

3. Check that the rear of the upper mounting boss of the guide leg is flush with the rear edge of the body flange of the guide leg (see Illustration 5).

2. Remove the door mirror assembly. (See Workshop Manual (JTIS CD ROM) section 501-09, SRO 76.10.52).

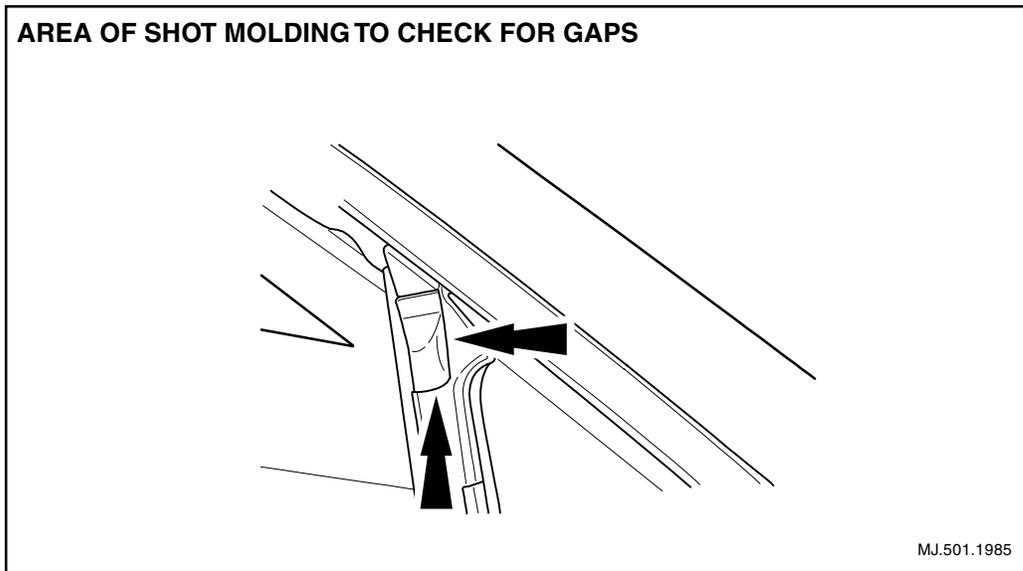
ILLUSTRATION 6

The shot molding must be flush, with no gaps, in the areas indicated by the arrows shown in Illustration 6.

- 4. Push down the waist finisher as required.
- 5. Readjust the flip seal ensuring even contact along the mirror base.

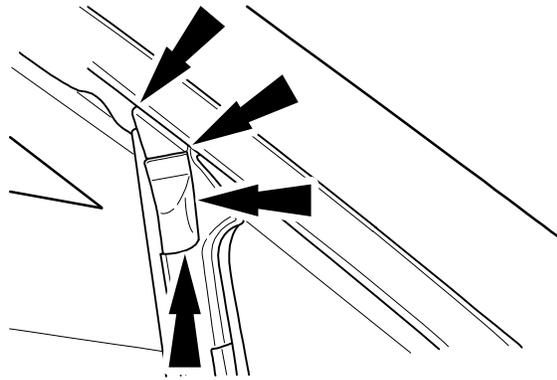
ILLUSTRATION 8

AREA TO BE SEALED USING SILICONE SEALER

7. Using a suitable silicone sealant, seal around the areas indicated by the arrows shown in Illustration 8, filling all the joints and holes.

Note: When sealing the areas shown in Illustration 8, ensure the sealant will not be visible when the mirror assembly has been re-installed.

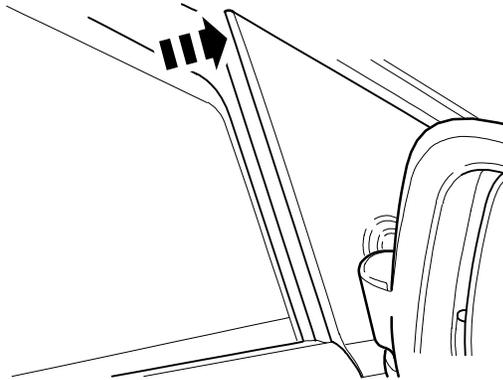
ILLUSTRATION 9

AREA TO BE SEALED USING SILICONE SEALER

8. Reinstall the mirror assembly ensuring the mirror base upper corner is forward (See Illustration 9) and the fixing stud contacts the body. (See Workshop Manual, JTIS CD ROM, section 501-09, SRO 76.10.52).
9. Reassess the fit of the mirror base to the glass seal. (Check against the dimensions shown in Illustration 3).
10. Evaluate.
