**Customer Intermittently Locked Out Of  
Vehicle After Closing Door –  
Install New Door Handle Damper**

MODEL 2001 MY-ON  
S-TYPE  
VIN M23023-ON

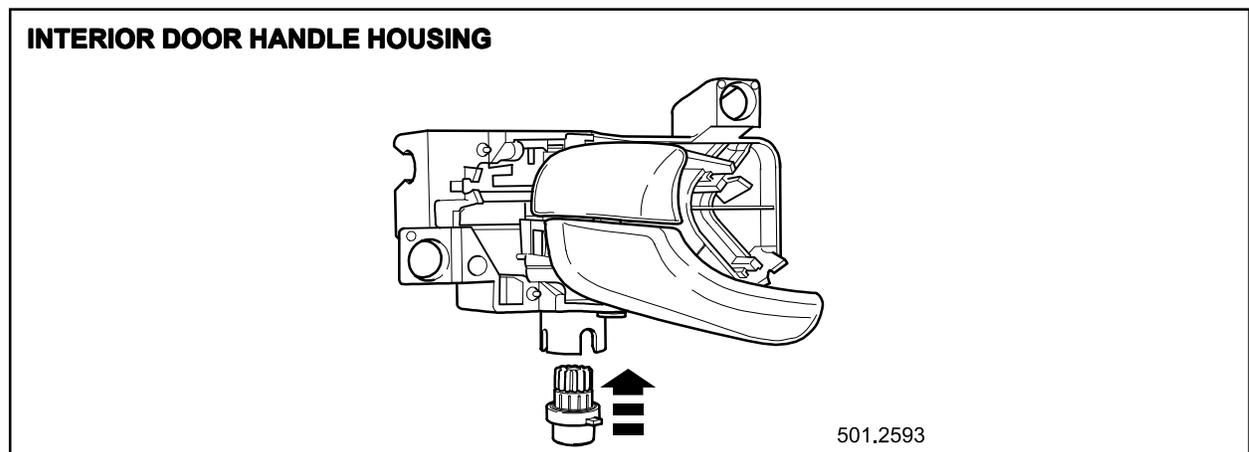
ILLUSTRATION 1

This problem may be caused by the interior handle springing back and activating the central locking. To address this concern, a new damper can be installed to both front interior door handles.

2. Install and fully seat the new damper into the interior door handle housing, ensure damper is located with a definite click (Illustration 1).
3. Install left hand front door trim panel (see Workshop Manual, JTIS CD ROM, section: 501-05, SRO 76.34.01).
4. Carry out steps 1 to 3 for the right hand side.
