**TECHNICAL BULLETIN**

Customer Intermittently Locked Out Of  
Vehicle After Closing Door –  
Install New Door Handle Damper

MODEL 2001 MY-ON  
S-TYPE  
VIN M23023-ON

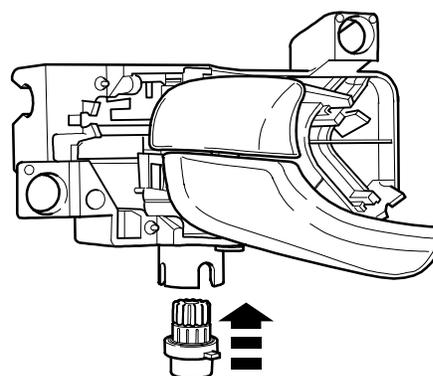
ILLUSTRATION 1

Some 2001 MY-ON S-TYPE vehicles **from the above VIN**, customers may have a concern of intermittently being locked out of the vehicle after closing a front door. This problem may be caused by the interior handle springing back and activating the central locking. To address this concern, a new damper can be installed to both front interior door handles.

**INTERIOR DOOR HANDLE HOUSING**

2. Install and fully seat the new damper into the interior door handle housing, ensure damper is located with a definite click (Illustration 1).
