X-TYPE

XT308-06

## TECHNICAL BULLETIN

Difficult/High Effort Engagement Into First Or  
Reverse – Clutch Disc Sticking –  
Regrease Input Splines

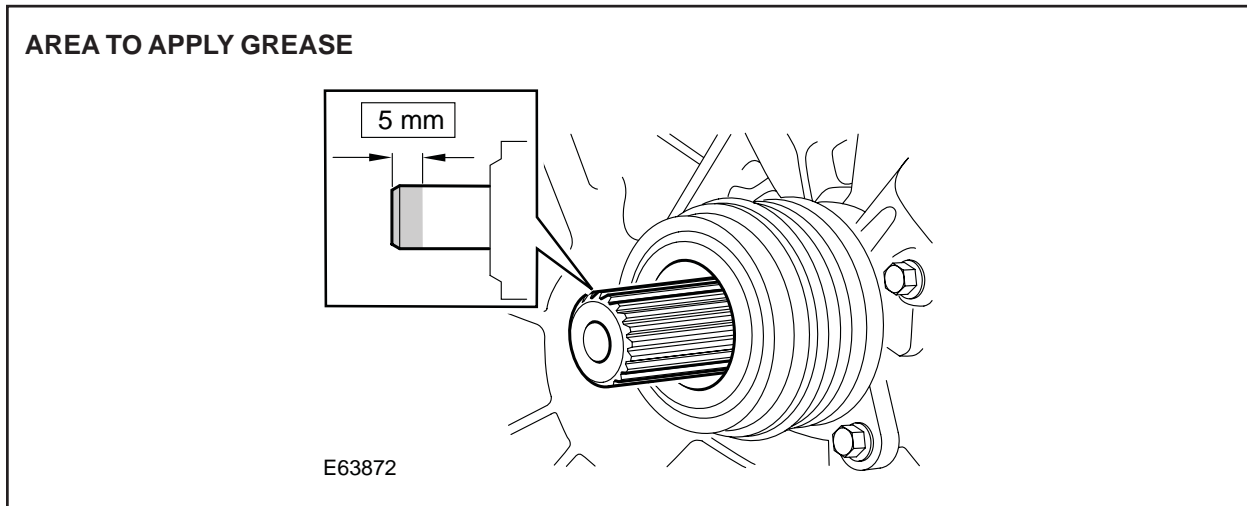
ILLUSTRATION 1

Some X-TYPE vehicles may exhibit difficulty engaging first or reverse gear, especially when the vehicle is cold. This can be caused by the clutch disc sticking on the transmission input shaft splines.

**Caution:** To much grease applied to the input shaft splines may lead to contamination of the clutch disc.

- Apply grease (specification ESD-M1C220-A or Castrol Pyroplex Red or Castrol Pyroplex Blue) to the circumference of the input shaft splines, not exceeding a length of 5 mm as shown in Illustration 1.
