MODEL
2007 XK

NUMBER
XK501-004

TECHNICAL BULLETIN

Console Ashtray Lid Will Not Remain Open, is Slow or Noisy

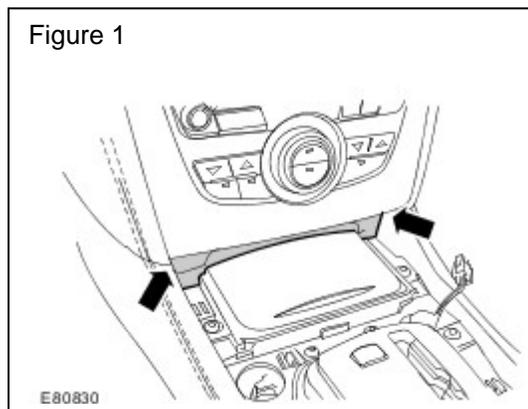
Figure 1

The ashtray lid veneer may be bowing, causing the ashtray lid veneer to contact the console trim panel.

CAUTION: To avoid damage to the components, the hooked screwdriver, or suitable tool, must be carefully inserted as high up the ashtray cover panel as possible when releasing the clips to remove the ashtray cover panel. (Arrowed in Figure 1)

2. Using a thin hooked screwdriver, or suitable tool, release the two clips securing the ashtray cover panel. (Arrowed in Figure 1)
3. Remove the ashtray cover panel.
4. Check operation of ashtray lid.
5. If the ashtray lid operation 'noise' has disappeared or the 'slow' operation has been resolved, modify the ashtray cover panel as follows:
 - Select a suitable fine file.
 - Lightly file along the lower edge of ashtray cover panel, removing only enough material to allow smooth operation of the ashtray lid. (Figure 2)
6. Install the ashtray cover panel.
7. Verify that the lid operates properly and no noise is present.
8. Refer to GTR Workshop Manual, section: 501-12 operation 76.47.26 and install the floor console veneer panel.
