TECHNICAL BULLETIN

AIR Pump Clutch – Intermittent Operation – Service Action S458

MODEL 1993-94 MY 4.0L Sedan & XJS DATE 5/97

**17-9
Amended
8/97**

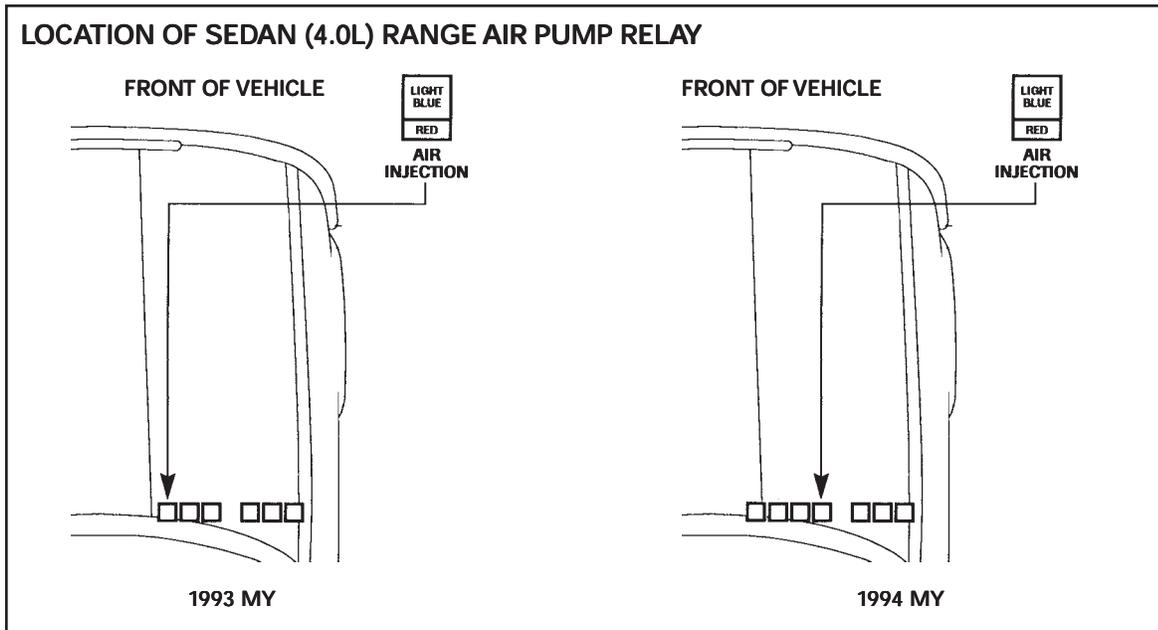
ILLUSTRATION 1

Some 1993-94 MY Sedan (4.0L) Range and XJS (4.0L) Range vehicles may experience intermittent operation of the AIR pump. The operation of the AIR pump clutch is controlled by a relay located in the engine compartment. The contacts of this relay may become contaminated by the entry of water or cleaning solutions containing silicones.

LOCATION OF XJS (4.0L) RANGE AIR PUMP RELAY

1. Open hood and replace the AIR pump relay (**red mounting base on Sedan; green mounting base on XJS**) with a sealed relay part no. LHF 6703AA.
2. Observe the AIR pump clutch while an assistant starts the engine. The clutch should engage as cranking begins. On a hot engine, the clutch should disengage after a few seconds. On a cold engine, more time will elapse until the clutch disengages at a coolant temperature of 34°C (95°F). Do not wait until the clutch disengages.
2. If proper operation is observed, no further action is required. Stop the engine and close the hood.
3. If the AIR pump clutch does not engage, follow normal diagnostic procedures (refer to AJ6 4.0L Engine Management System/OBD I Diagnostic Guide) and repair. Submit a claim under normal warranty procedures.
