TECHNICAL BULLETIN

Intermittent Power Loss – Tach Drops to Zero – Reposition Ignition Amplifier – Service Action S 439

18-41

MODEL XJS V12 Range 1994 MY

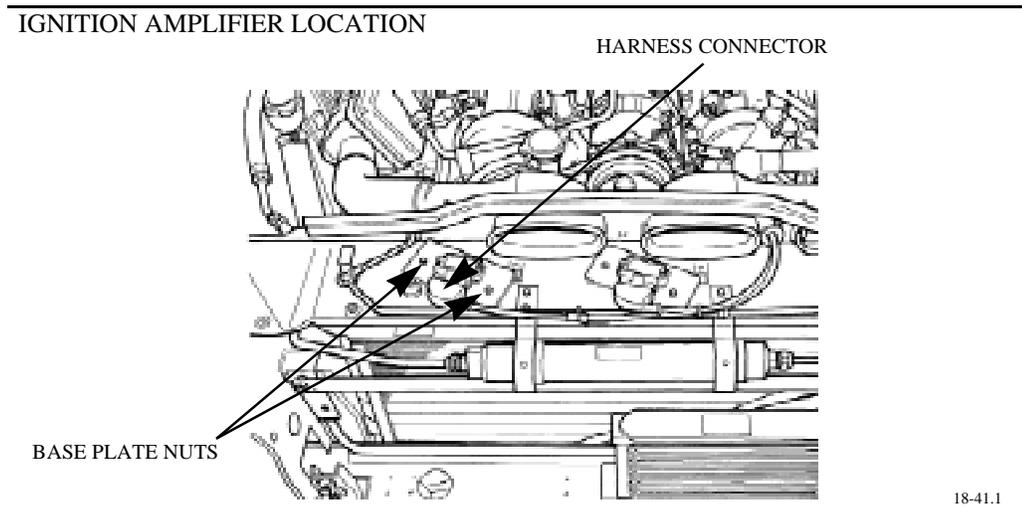
ILLUSTRATION 1

Symptoms of intermittent power loss or engine misfire, with the tachometer needle dropping to zero, may be caused by the under hood liner coming into contact with the “A” bank (right) ignition amplifier connector housing. This may cause damage to the right side primary catalytic converter. To prevent this contact from occurring, the ignition amplifier was repositioned at VIN 194707.

1. Disconnect the “A” bank (right) ignition amplifier harness connector and remove the two amplifier base plate nuts (Illustration 1).
