# TECHNICAL BULLETIN

## Rough Idle/Engine Misfire – New Spark Plug Wires and Routing

**18-43**

MODEL XJS Range (V12) and XJ12      DATE 11/94

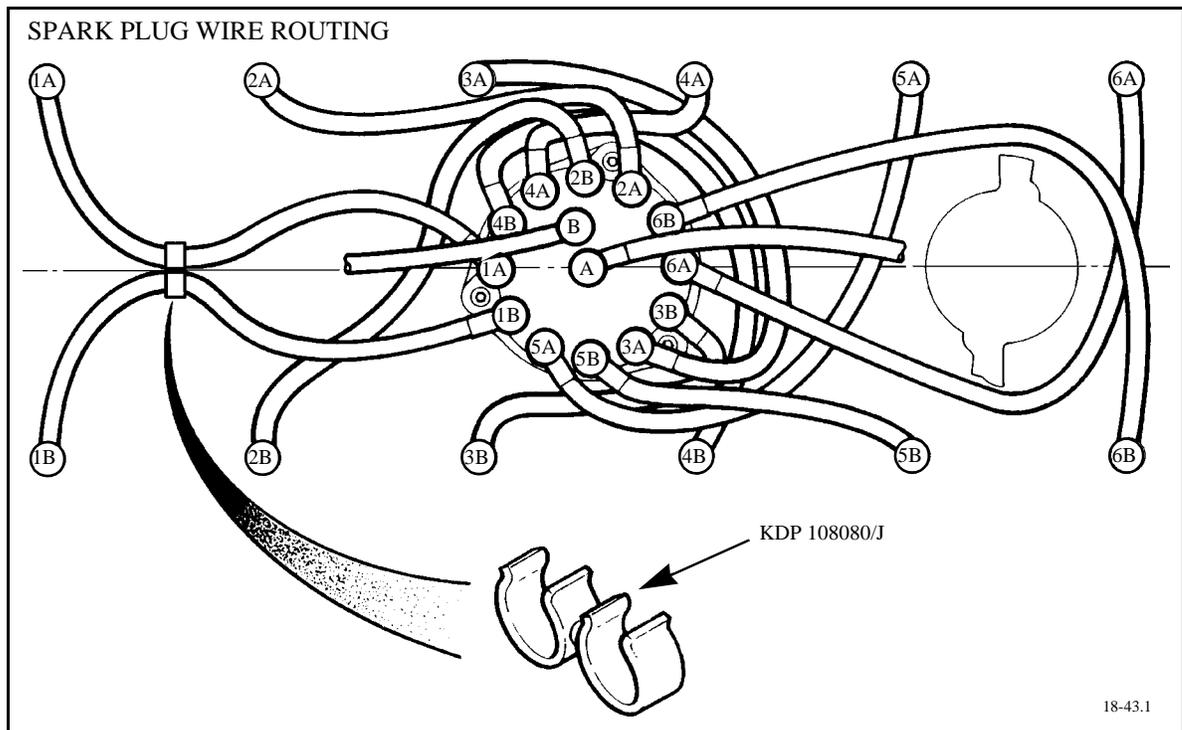
ILLUSTRATION 1

Rough idle and engine misfire conditions that develop after approximately 20,000 miles may be caused by high voltage leaks between the spark plug wires and cylinder head bolts.

Route the new wires as shown in Illustration 1.

**IMPORTANT:** The clip (P/N KDP 108080/J) must be installed on the spark plug wires for cylinders 1A and 1 B as shown in the illustration.
