TECHNICAL BULLETIN

Intermittent High Idle – Replace Throttle Return Springs

19-33

MODEL XJ12 (6.0L) 1994 MY

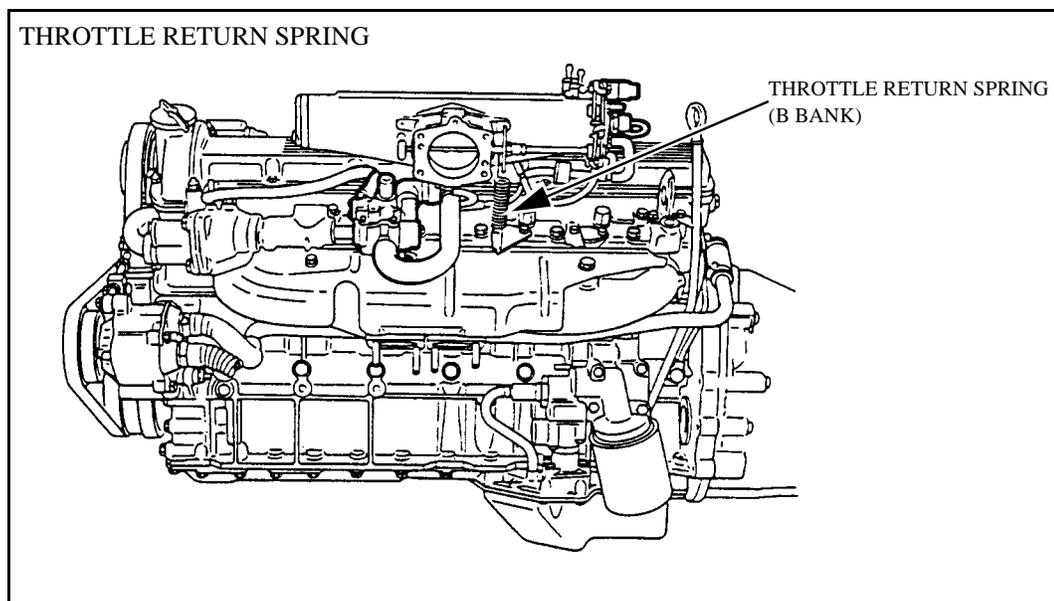
ILLUSTRATION 1

Some 1994 MY XJ12 Sedan Range vehicles may experience an intermittent high idle speed of approximately 900 rpm (normal idle speed, 750 rpm in neutral). This condition occurs when slowly returning the throttle to the idle position.

1. Remove throttle return spring from the throttle body, Illustration 1.
2. Install the new spring first to the bracket, then to the throttle lever.
3. Repeat the procedure on the throttle body on the opposite bank.
4. Check for correct throttle return operation.
