TECHNICAL BULLETIN

Seat Track Assembly – Repair/Replace Guidelines

76-129

MODEL 1993-94 MY Sedan Range

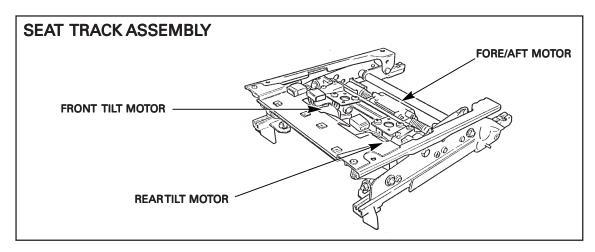
ILLUSTRATION 1

The entire seat track assembly (Illustration 1) on the above vehicles does not need to be replaced when the fore/aft motors or cushion tilt motor, gearbox, or potentiometer is inoperative. These motors/gearboxes/potentiometers are available separately from the seat track assembly. This bulletin describes under what conditions replacing the seat track assembly is not justified.

Do **not** replace the complete seat track assembly under following conditions:

- the cushion tilt motor is damaged.
- the potentiometer for the cushion tilt motor is damaged.
- the transmission of the cushion tilt motor is damaged.
- the fore/aft motor is damaged.
- the potentiometer for the fore/aft motor is damaged.
- the transmission shafts for the fore/aft motor are stripped.

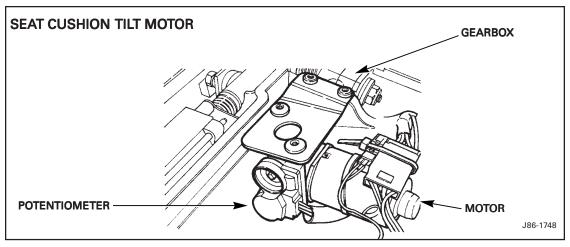
ILLUSTRATION 2

Refer to Volume 4, Section 86, pages 86-77 to 86-88 of the XJ6-XJ12 Saloon Range Service Manual for the procedures to replace the motors and/or potentiometers. Since the cushion tilt motors come as an assembly with the gearboxes and potentiometers, (Illustration 2) the relationship between the linkage and the potentiometer is already set.
