TECHNICAL BULLETIN

Heated Windshield Washer (Screenwash) Jets – Ambient Temperature Sensor Added – Service Action S447

MODEL XJS Range 1994 - 1995 MY DATE 12/94

84-12
Amended
1/95

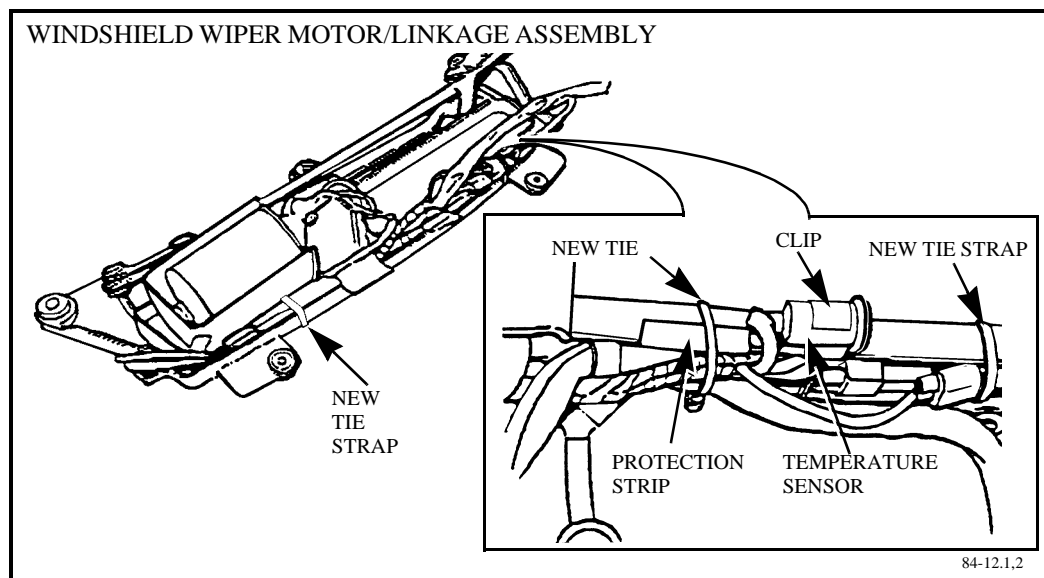
ILLUSTRATION 1

Heated windshield washer jets may cause distortion of the washer jet housings or the plenum grille during prolonged use.. An ambient temperature sensor was added to the system in production at VIN 196047.

1. Ensure that the radio code is available. Record all preset radio stations (including X-mem) and disconnect the negative cable of the battery.
2. Remove the windshield wiper motor/linkage assembly following the instructions in the XJS Service Manual section 84.15.12.
3. Cut the tie straps, remove and discard the washer jets and the washer jet link harness.
4. Fit the temperature sensor clip and chafing protection strip to the wiper motor/linkage assembly frame (Illustration 1).
5. Route the new washer jet link harness and fully seat the temperature sensor under the clip.

6. Fit new washer jet assemblies, connecting them to the washer fluid lines and the link harness.
7. Connect the link harness to the wiper harness multi plug and fit the “blanking plug” to the open connector of the link harness (red and black wires).
8. Position the washer jets with the link harness and washer fluid lines in the frame channels.
9. Use three tie straps, in the positions indicated in Illustration 1, to secure the washer fluid lines and link harness.
