**Scraping Noise – Front Brake Disc Shield –
Install Washer**

MODEL 1997 MY
XK8 Range
VIN
001001-005660

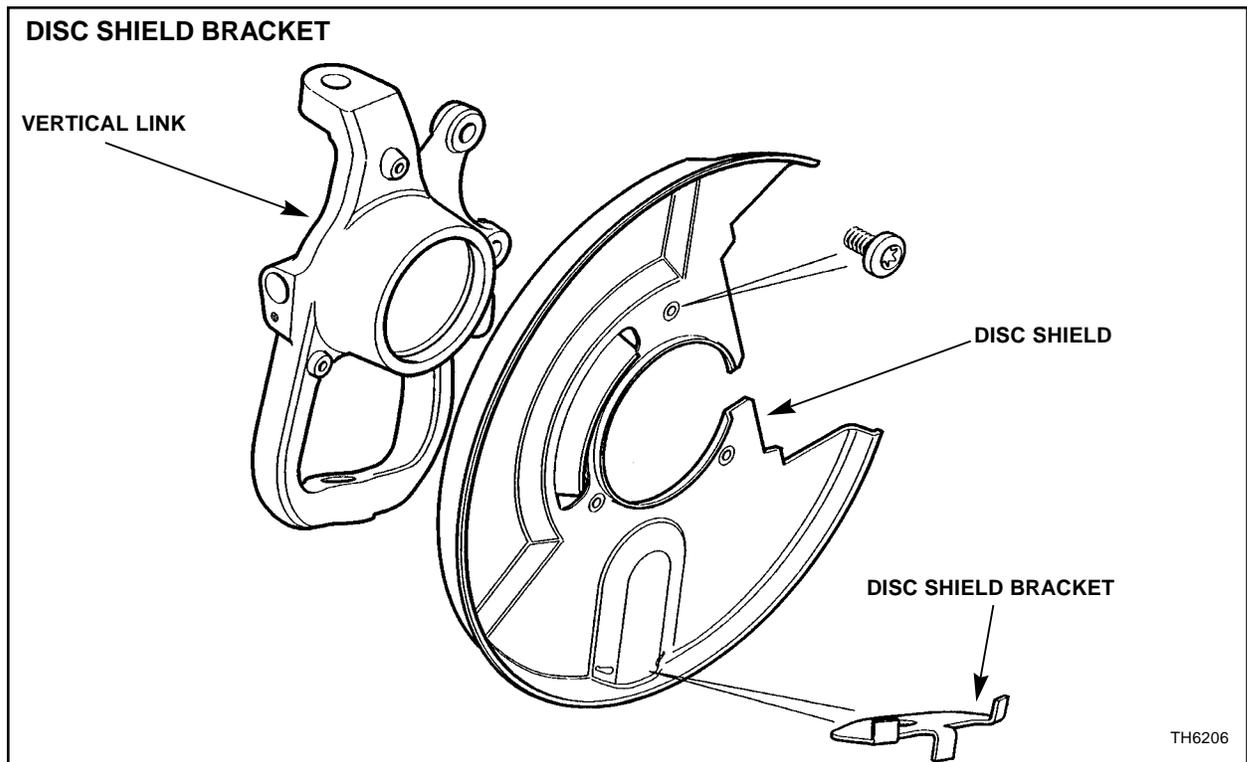
ILLUSTRATION 1

Some 1997 MY XK8 vehicles within the above VIN range may experience a scraping noise from the front brake area. This noise may be caused by light contact between the brake disc and its shield. Evidence of light contact may be visible on the shield.

The condition can be caused by the shield bracket having twisted as the bottom ball joint retaining nut was tightened. A washer was introduced in production from VIN 005661, that is installed between each bottom ball joint retaining nut and the retaining bracket of the disc shield, to prevent it from twisting.

1. Remove the bottom ball joint nut.
2. Examine the bracket (Illustration 1) for possible cracks or other damage.

3. Eliminate any distortion in the shield.
4. Install a washer, part no. WA 112081/J, then the ball joint retaining nut.
5. Make sure that the bracket does not twist as the nut is tightened. Torque to nut to 52 lb. ft. (70 Nm.)
