**A-Bank Camshaft Sensor Harness Contacting  
EGR Pipe – Check/Install Tie Strap –  
Service Action S704**MODEL 2001 MY  
XJR

VIN F21393-F22436

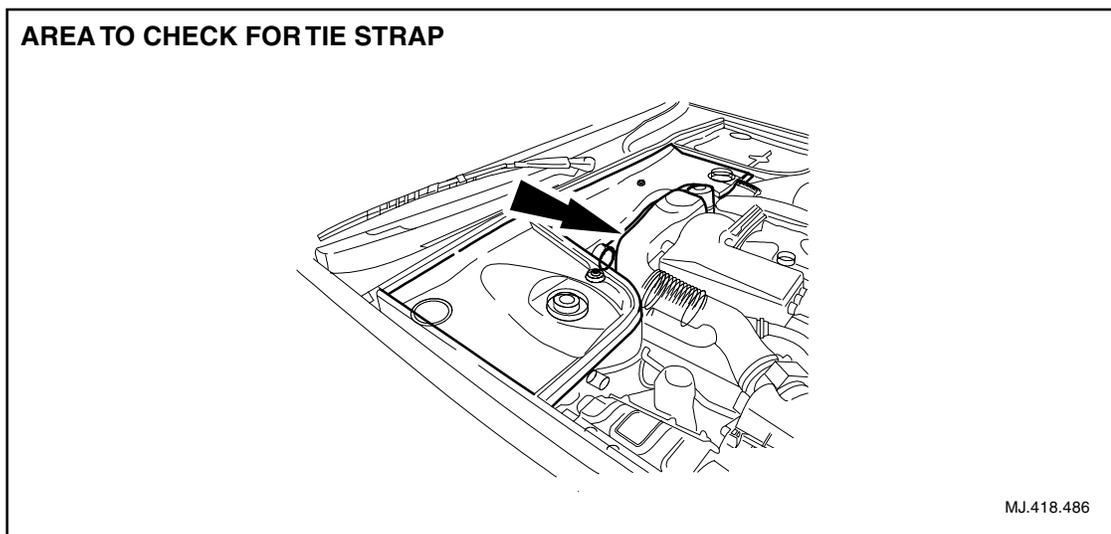
ILLUSTRATION 1

1. Open the hood and place protective covers over the fenders.
2. Look down into the area shown in Illustration 1.

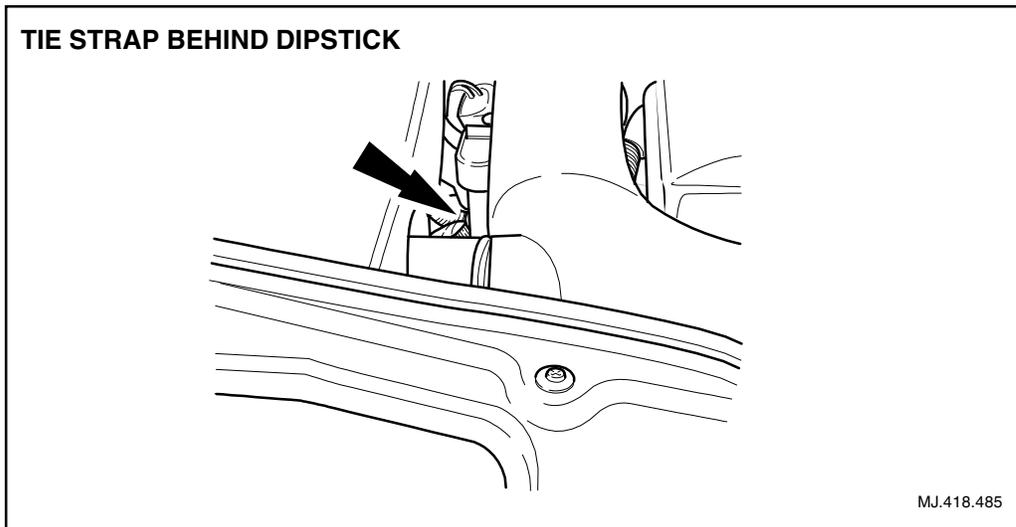
ILLUSTRATION 2

3. The tie strap (if fitted) locates around the camshaft sensor harness behind the oil dipstick (Illustration 2).

**NOTE:** If no tie strap is present, proceed to the engine harness routing modification below.

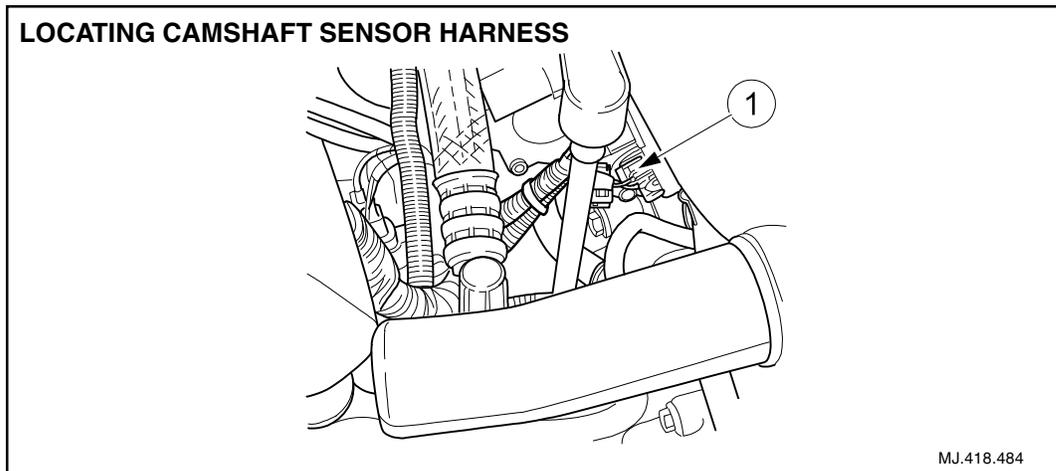
ILLUSTRATION 7

**NOTE:** Locate the camshaft sensor harness by tracing it back from the connector shown in Illustration 7.  
The camshaft harness connector is shown as item 1 (Illustration 7).
