Sedan Range

03.2-03

## Engine Crankcase – Oil Leaks - Sealing Procedure

MODEL 1995 MY-ON  
XJ12 Sedan

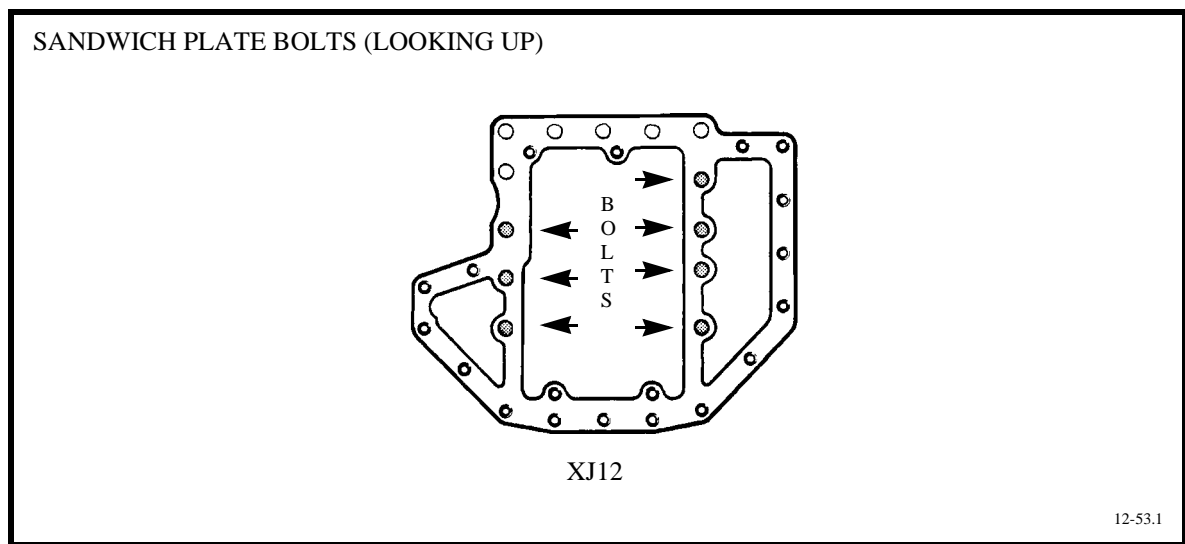
ILLUSTRATION 1

Oil leakage at the crankcase joints of V12 engines.

For oil leaks at the oil pan gasket or at the baffle tray and sandwich plate bolts, perform the following:

1. Remove the oil pan.
2. Remove the sandwich plate and the 7 baffle tray bolts shown in Illustration 1.

3. Thoroughly clean the bolts and bolt hole threads.

4. Apply Loctite Primer to the bolt hole threads.
5. Apply Loctite 545 to the sandwich plate and baffle tray bolts. Install and torque the bolts to 16 - 20 lb ft (21 - 27 Nm).
6. Install the oil pan with a new gasket and torque to 6 - 20 lb ft (21 - 27 Nm).
