Sedan Range

08.2-01

TECHNICAL BULLETIN

Transmission MIL Illumination – Revised EPROM – Replacement Procedure

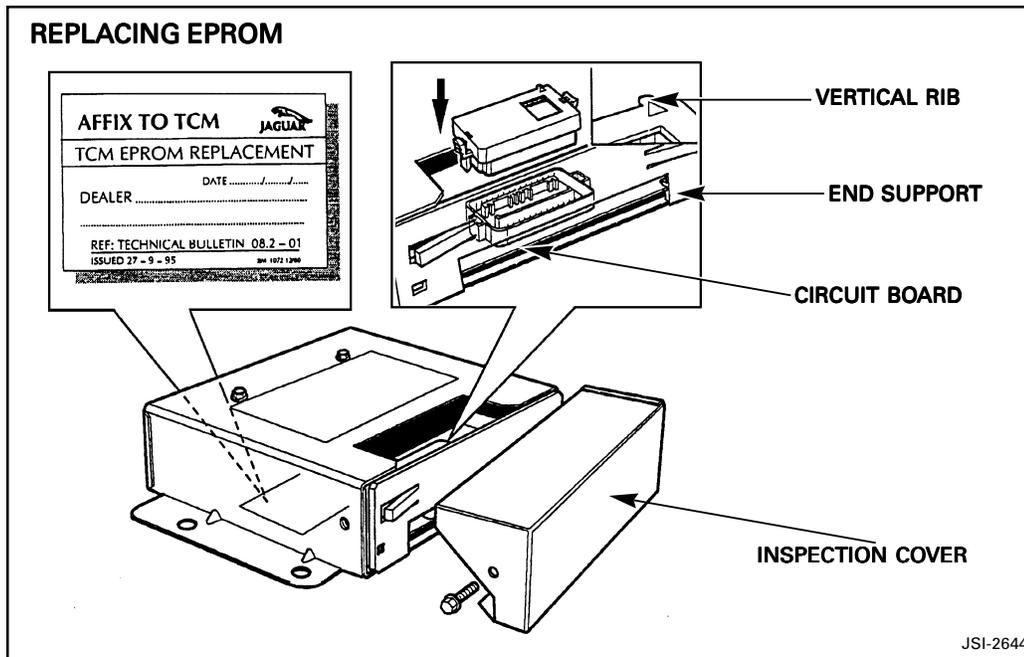
ILLUSTRATION 3

CAUTION! The end support (Illustration 3) is free to move when the inspection cover is removed and must be held in place. Support the circuit board through the opening in the end support to prevent the board from bending and possibly cracking while removing and installing the EPROM.

5. Place the TCM on a clean bench area and remove the TCM inspection cover (Illustration 3).

6. The EPROM has a retaining latch at each end. These latches must be pressed in while removing the EPROM from the socket. Press the latches inward and ease each latch free of the socket. Then, carefully remove the EPROM module from the circuit board.
7. Align the vertical rib (Illustration 3), indicated by an arrow, on the replacement EPROM with the rib on the socket to ensure correct alignment.

Install the replacement EPROM module in the board socket while holding the board through the opening in the end support. Press the EPROM down into the socket until the latches engage.
