Sedan Range

10-02

## Front Wheel Arch Liner – Noise During Tight Turns – Repair Procedure

MODEL 1995 MY  
XJR Sedan

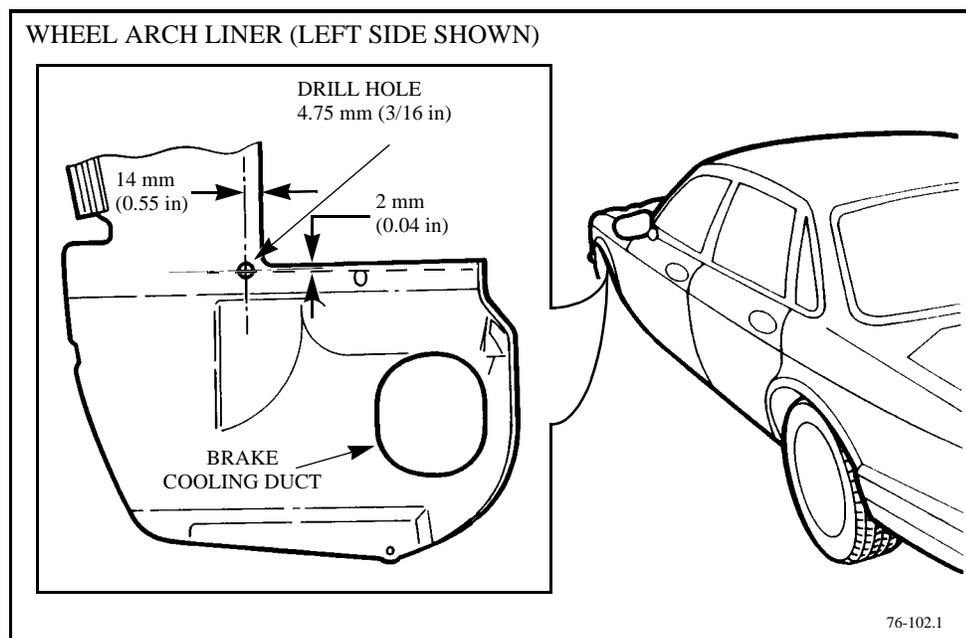
ILLUSTRATION 1

Noise from the front wheel arch area during tight turns. The front tires of 1995 MY XJR Sedans from VIN 720001 - 723157 may contact the wheel arch liner during full lock turns.

1. Remove both front wheels.
2. Mark two lines parallel with the inside edges of the wheel arch liner using the dimensions shown in Illustration 1.
3. Drill a 4.75mm (3/16 inch) diameter hole through the liner and the body panel at the point where the two lines cross.
