Incorrect Speaker Mapping, Alternator Whine – Premium Sound System – DIN Plug Damage

MODEL 1995 MY
Sedan Range
VIN 720001-ON

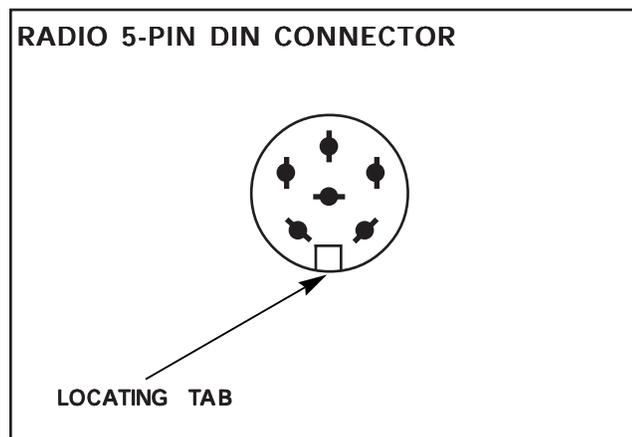
ILLUSTRATION 1

When reconnecting the grey 5-pin DIN plug at the rear of the premium sound system radio, it is possible to force the connectors together improperly. The connector can be accidentally assembled 180 degrees out of alignment due to the thin diameter of the male pins.

If this occurs, the shield wire is left open, allowing alternator whine to be heard through the speakers. In addition, the outputs leading to the Harmon-Kardon amplifier are reversed causing reversed operation of the fader and balance controls.

The male pins may also be damaged beyond repair.

When reconnecting the 5-pin DIN connector, check that the locating tab is positioned at the bottom, Illustration 1.
