**Damaged Wiring Harness – Possible Intermittent Engine Misfire/No Start – Remove Harness Clip**

MODEL 1995-96 MY  
Sedan Range  
VIN  
720001-770946

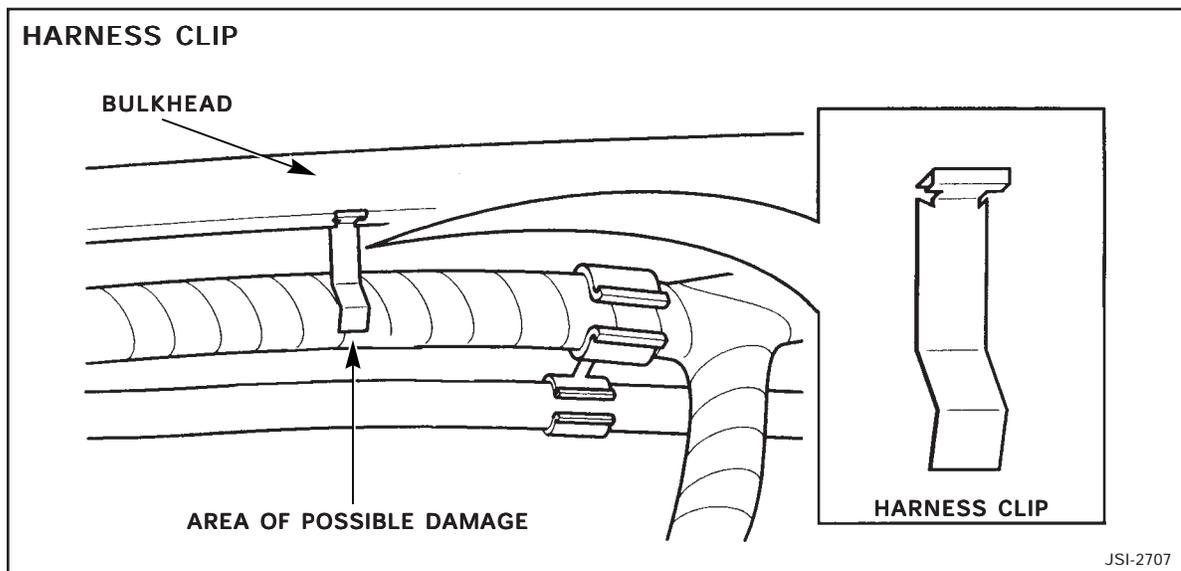
ILLUSTRATION 1

Some Sedan Range vehicles within the above VIN range may exhibit a condition of engine misfire/no start, which can be caused by a clip shorting the engine management harness to ground. The clip, which is located on the bulkhead on the right side of the engine compartment (Illustration 1), may cut into the harness causing a short circuit.

The clip is not found in this location on all vehicles and was deleted from the vehicle build specification after VIN 770946.

Remove and discard the clip on all vehicles where it is found, to eliminate the possibility of it penetrating the harness.

In case of a customer complaint of engine misfire/no start, check if the clip is present and if it has penetrated the harness. Remove and discard the clip. Test to verify if the harness has been damaged and repair as needed.
