**Squeaks & Rattles – Traction Control Cable
– Check Cable Position**

MODEL 1995-96 MY
Sedan Range

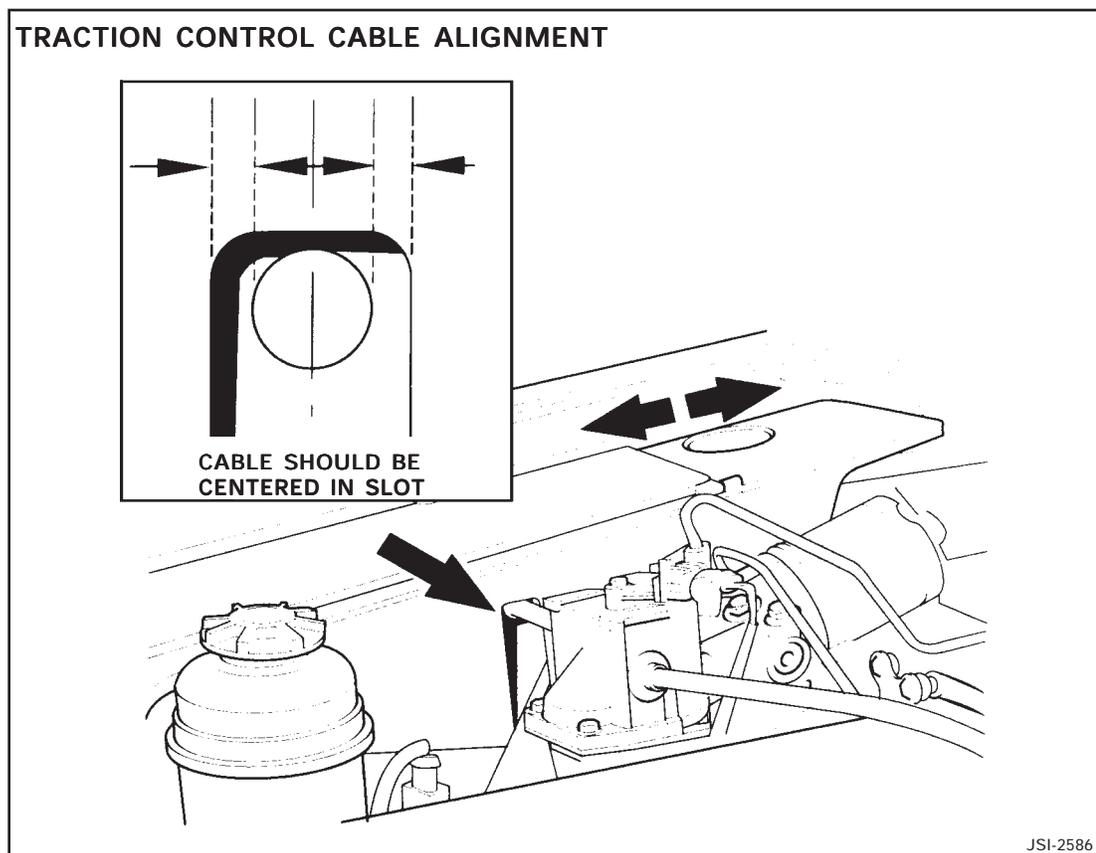
ILLUSTRATION 1

Some 1995 MY-ON Sedan Range vehicles with traction control may experience a noise coming from the right side of the fascia/bulkhead/under hood area. The noise may be caused by contact between the throttle cable casing and the slot in the right side tool box.

After verifying a customer complaint of noise as described above on a 1995 MY-ON Sedan Range vehicle with traction control, check that the throttle cable is centered in the toolbox assembly slot (Illustration 1).

If the cable is not positioned in the center of the slot, note the position and proceed as described on the next page.

CENTERING THE TRACTION CONTROL THROTTLE CABLE

1. Remove the toolbox assembly.
2. If the cable position requires adjustment, release the cable clip and reposition the cable as needed.
3. Position the toolbox, without securing it, to check that the cable position is correct.
4. After the cable is centered properly as in Illustration 1, secure the toolbox assembly.
