19.7-03

TECHNICAL BULLETIN

Knocking from Front Suspension – Shock Absorber Mounting – Repair Procedure

MODEL 1995-96 MY
Sedan Range
VIN
720001-ON

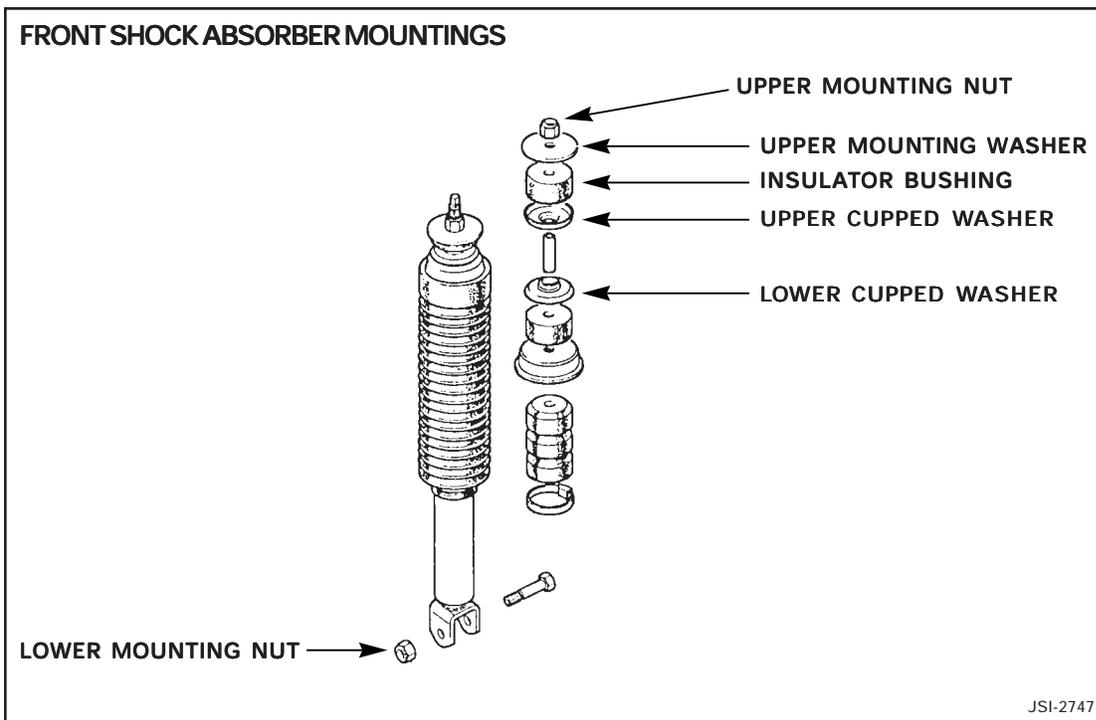
ILLUSTRATION 1

Some 1995-96 MY Sedan Range vehicles may experience knocking noises from the front shock absorbers.

2. Check that the shock absorber upper cupped washer (Illustration 1) is fully seated against the inner fender panel in the engine compartment.
3. Remove the upper mounting nut (illustration 1) and remove the upper mounting washer and insulator bushing.
4. Inspect the cupped washer. If the washer is distorted or damaged in any way, install a new cup washer (part no. CBC 5431). Reassemble the bushing and cup washer, ensuring that the cup washer is correctly seated against the body. Always install a new nut (part no. JZN 100013) and torque to 26 lb. ft. (35 Nm).
5. Repeat steps 1-4 on the opposite side of the vehicle.
6. Reinstall components removed in step 1.

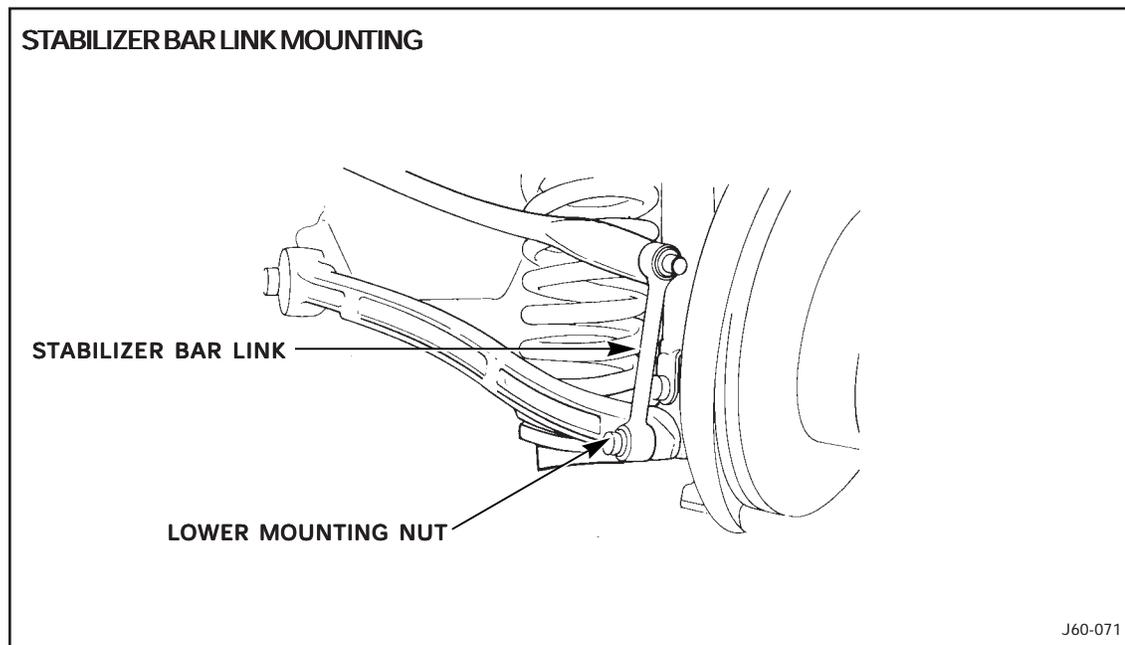
ILLUSTRATION 2

To overcome concerns of knocking noises from the lower shock absorber mounting, the torque specification for the mounting nut has been raised to 51.6 lb. ft. (70 Nm) from VIN 777889.

1. After performing the above inspection, raise the vehicle on a lift so the front suspension hangs fully extended.
2. Remove the mounting nut (Illustration 2) from the lower mounting of the stabilizer bar link. Discard the nut. Move the link aside to allow access to the lower mounting of the shock absorber.
3. Remove and discard the existing lower mounting nut (Illustration 1) from the lower mounting bolt of each shock absorber.
4. Install a new mounting nut (part no. JZN 100013) and torque to 51.6 lb. ft. (70 Nm).

5. Reinstall the stabilizer bar link using a new nut (part no. JZN 100013) and torque to 70 lb. ft. (95 Nm).
6. Repeat steps 1-5 on the opposite side of the vehicle.
