Rattle –
Rear of Vehicle Underbody –
Repair Procedure

MODEL 1995-97 MY
Sedan Range
VIN 720001-812255

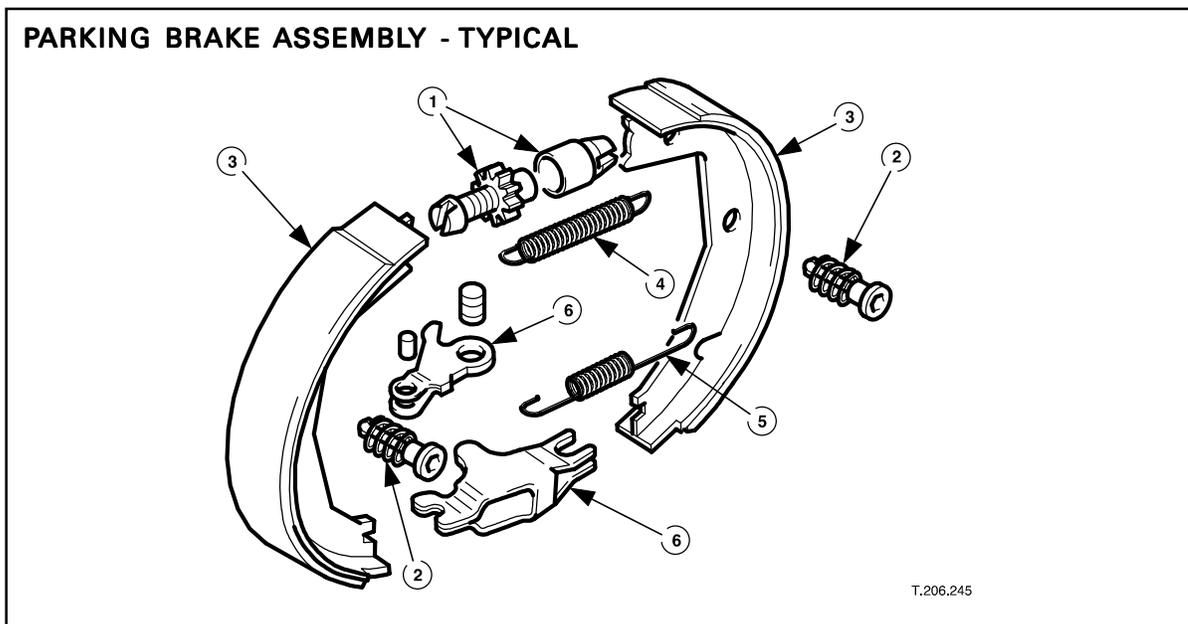
ILLUSTRATION 1

On 1995-97 MY Sedan Range vehicles, a rear-end underbody rattle may be caused by the parking brake mechanism.

Install rubber sleeves over each parking brake shoe lower return spring (Item 5, Illustration 1). The sleeves will exert pressure on the parking brake shoe spreader mechanism, to prevent it from rattling against the backing plate under certain conditions.

1. Raise and support the rear of the vehicle. Ensure that the parking brake is fully released.
2. Remove the rear wheels.
3. Disconnect the rear brake calipers, supporting them clear of the rear brake discs.
4. Without disturbing the adjustment of the parking brake shoes, remove the brake discs.
5. Release and remove the brake shoe lower return springs.
6. Slide a rubber sleeve over each spring. (See Parts Information).
7. Reinstall the springs, ensuring that the rubber sleeves are centered on each spring and that the sleeves exert a moderate pressure on the shoe spreader mechanism.
8. Reinstall the brake discs, pads, calipers and road wheels.
