**Cooling System Bleed Lines –
Correct Routing – Model Year Differences**

MODEL 1997 MY-ON
XK8 Range
VIN 001001-ON

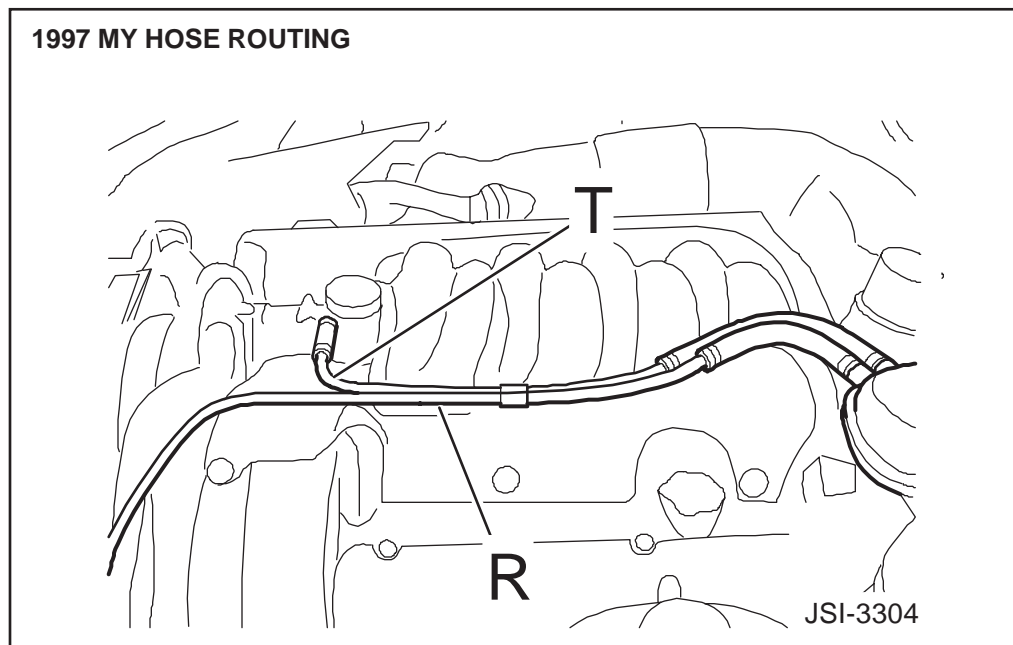
ILLUSTRATION 1

1997 Model Year Condition VIN 001001 - 018107

- Reservoir: Part No. MJA 4400AC for 1997 MY **only**.
- Bleed line R, Illustration 1, from radiator is connected to **front** fitting on reservoir (Illustration 1).
- Bleed Line T from thermostat is connected to **rear** fitting on reservoir.

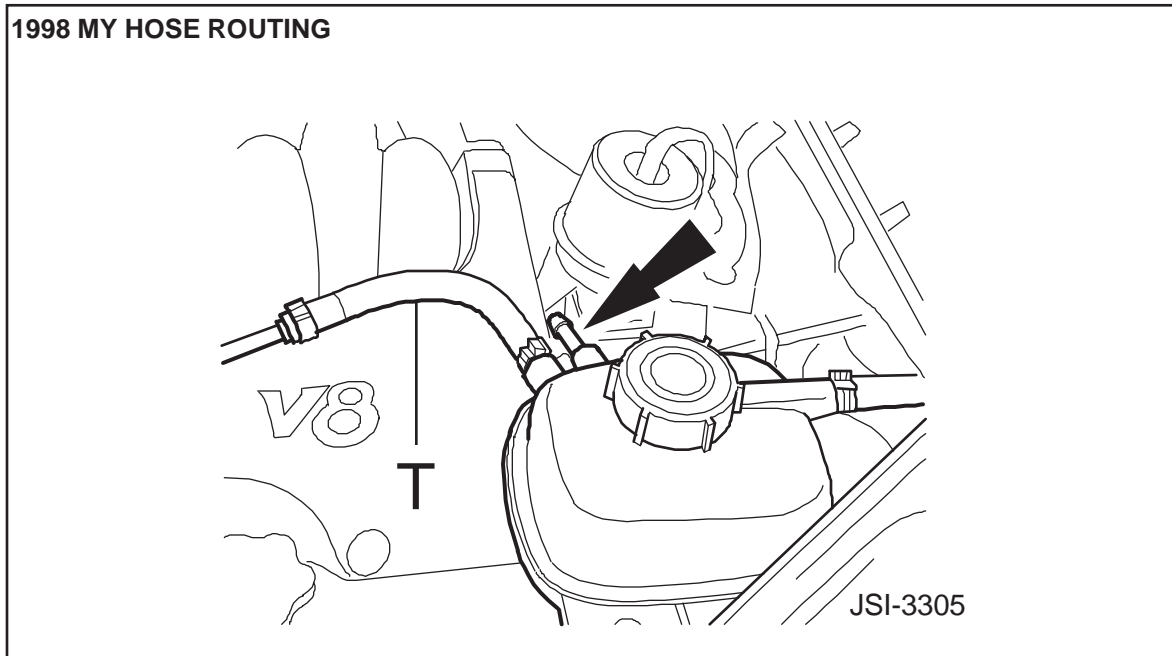
ILLUSTRATION 2

1998 Model Year Condition VIN 018108 ONWARDS

- Reservoir: **Part No. changed to MJA 4400AD** for 1998 MY.
- Bleed Line T from thermostat is connected to **front** fitting on the reservoir (Illustration 2).

Note: There is **no** bleed line from the radiator. This has proved to be unnecessary.

- The **rear** fitting of the reservoir (not connected) is **plugged**.
