Wiring Change –  
Driver Seat Control Module –  
Modification Instructions

MODEL 1997 MY  
XK8 Range  
VIN 001001-003300

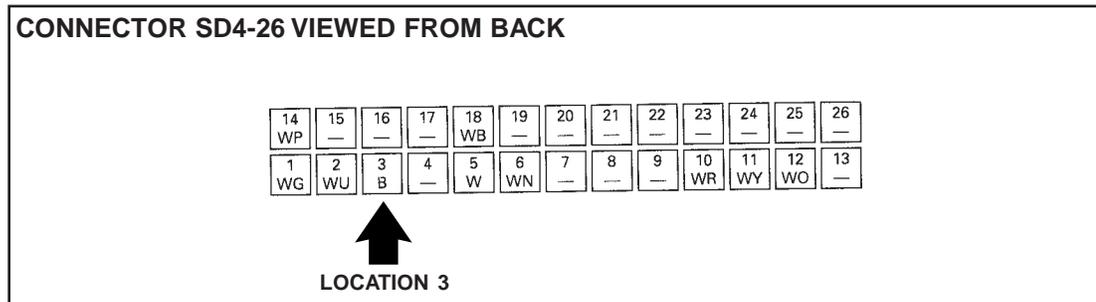
ILLUSTRATION 1

Early 1997 MY XK8 vehicles (up to VIN 003300) have a ground wire for the Driver Seat Control Module (DSCM) at location 3 of connector SD4. This ground circuit enables the control module to function as a DSCM instead of as a Passenger Seat Control Module (PSCM). On vehicles after VIN 003300, the ground wire was moved to location 1 on connector SD5. Since the early DSCM (LJA 2160AE/001) supersedes to LJA 2160AG/001, the wiring must be updated to the later configuration for the later DSCM to operate correctly. Without the ground, the control module will operate as a PSCM meaning that memory settings will not function and the key chime will not sound. Refer to Fig. 12.1 of the 1997 MY XK8 Electrical Guide for further information.

2. Disassemble the SD4/26 center connector to remove the black wire from location 3 (Illustration 1). Verify that the black wire is connected to body ground.
3. Reassemble the SD4/26 connector.
4. Remove the terminal from the black wire. Splice on a lead with a molex connector terminal already crimped on (part no. 418-083 supplied in the wiring harness repair kit 418-S065).
5. Pull out the red lock on connector SD5/10 to unlock the terminals.
