Water Ingress Around Roof Opening Panel –
Restricted Drain Tubes –
Check/Reposition Drain Tubes

MODEL 2004-05 MY
XJ range

VIN G00001-G38526

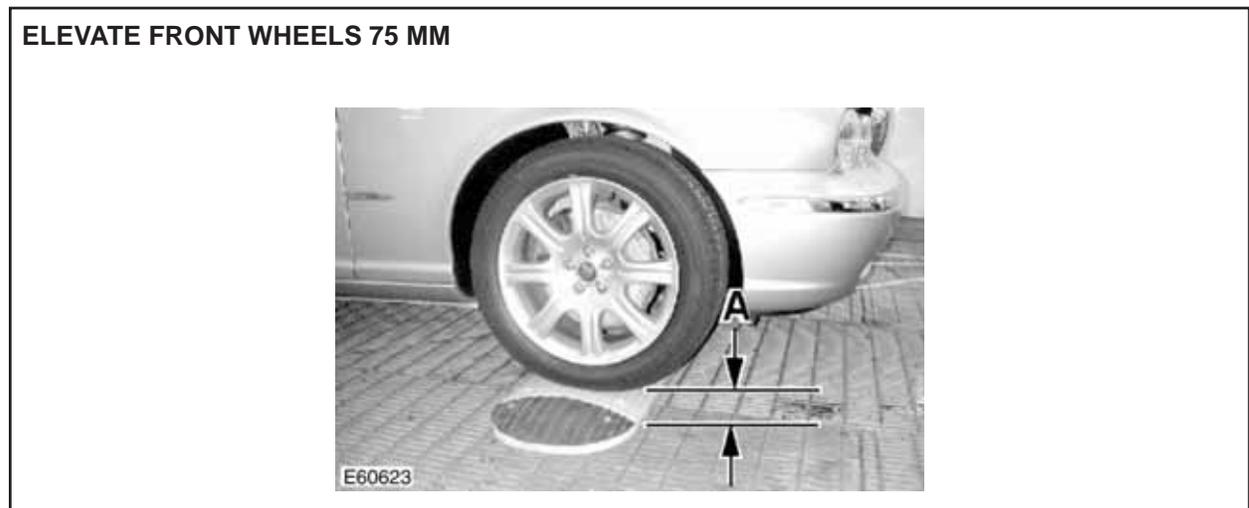
ILLUSTRATION 1

1. Drive the vehicle onto a suitable raised surface so the front wheels are approximately 75 mm (3 in) higher than the rear wheels (Illustration 1).

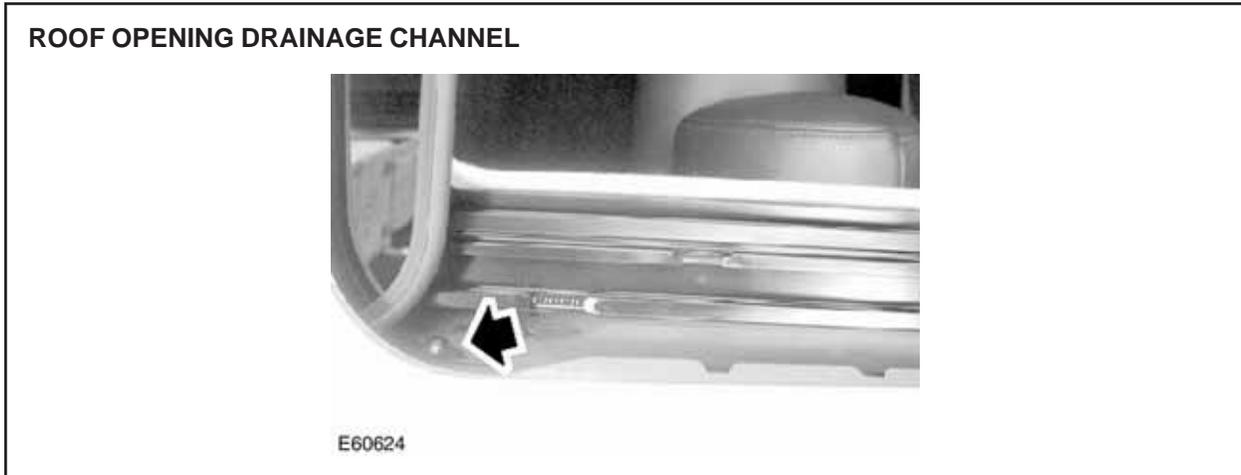
ILLUSTRATION 2

3. Use a suitable container/bottle to slowly pour water into the roof opening panel drainage channel (Illustration 2).

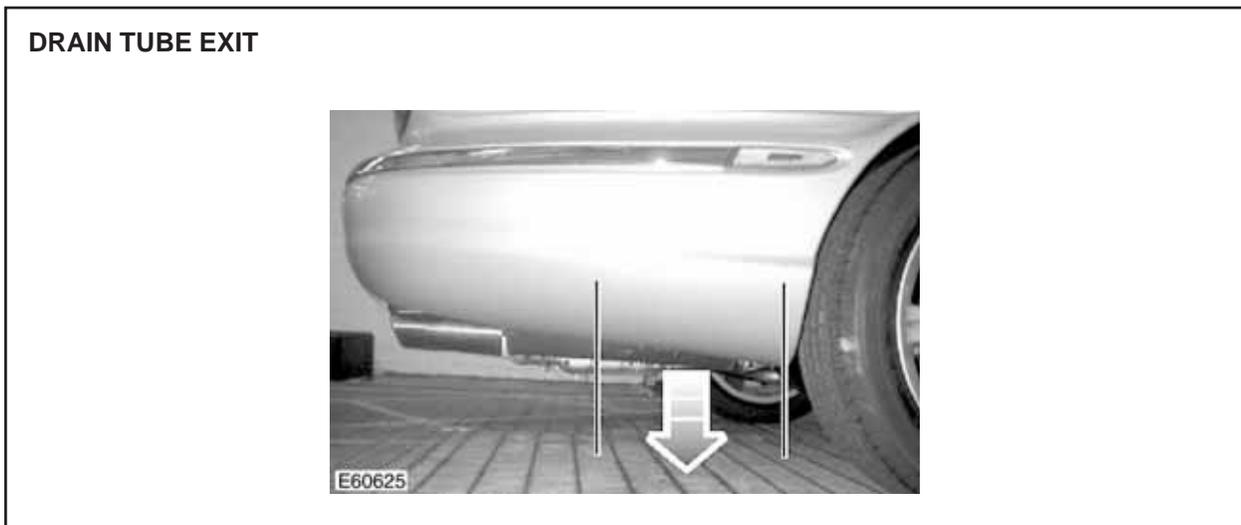
ILLUSTRATION 3

4. With assistance, look for water flowing onto the floor from the drain tubes located behind the rear wheels (Illustration 3).

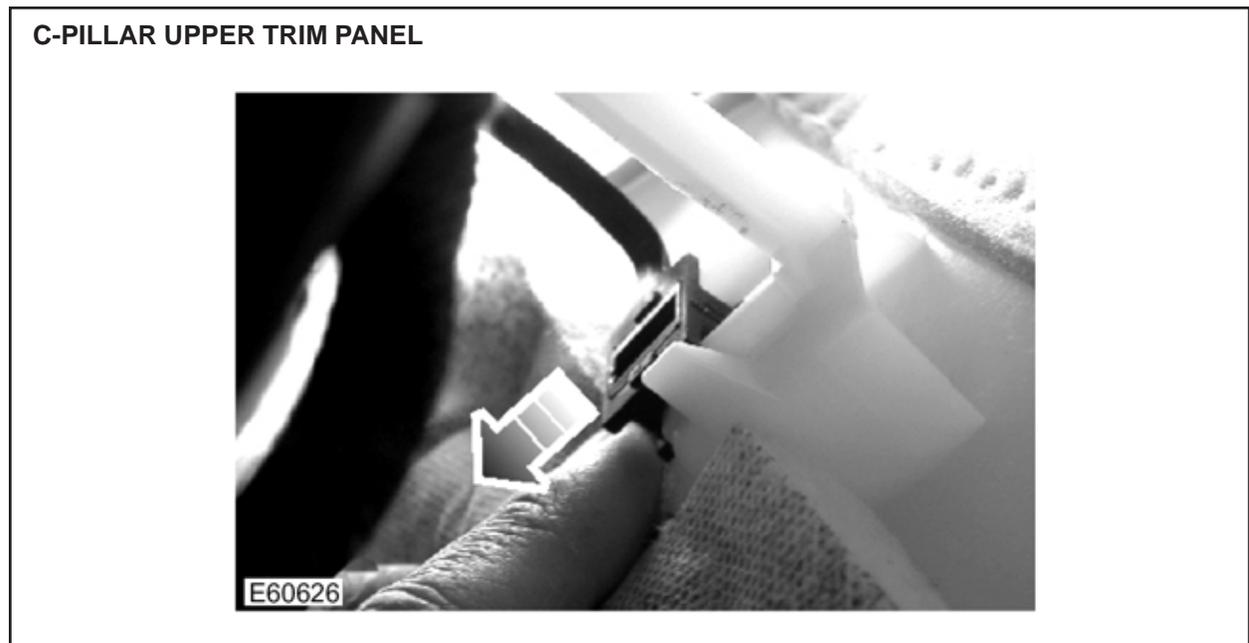
ILLUSTRATION 4

10. Carefully detach the C-pillar upper trim panel. Slide the retaining strap downwards to detach the strap from the trim panel, and place the trim panel on the rear parcel shelf (Illustration 4).

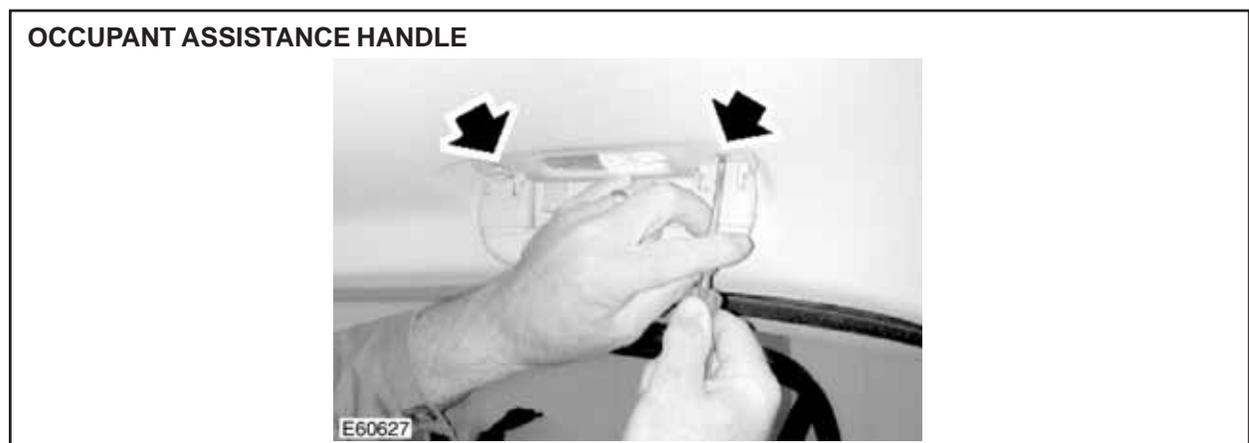
ILLUSTRATION 5

11. Note the fitted position of the washers and then remove the rear occupant assistance handle (Illustration 5).

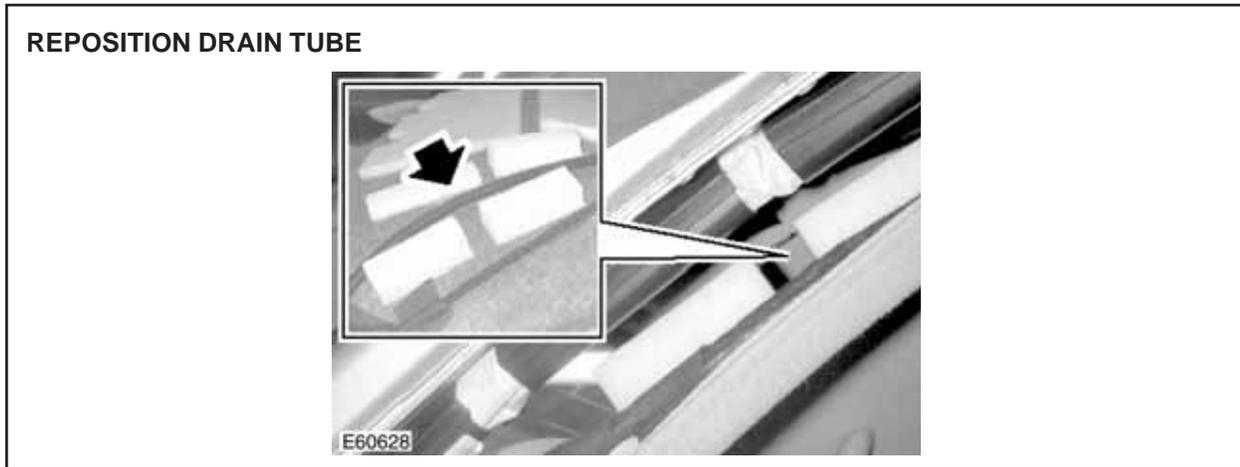
ILLUSTRATION 6

12. Carefully lower the rear corner of the headlining sufficiently to gain access to the drain tube.
13. Remove and discard the adhesive tape securing the drain tube to the roof panel.
14. Reposition the drain tube between the white foam blocks (Illustration 6).

15. Reposition the headlining to the roof panel, ensuring the drain tube remains between the white foam blocks.
16. Position the rear occupant assistance handle to the headlining, ensuring the washers are fitted correctly. Install screws and torque to 1.5Nm (1.11 lbf.ft).
17. Reposition excess drain tube downwards past parcel shelf edge.

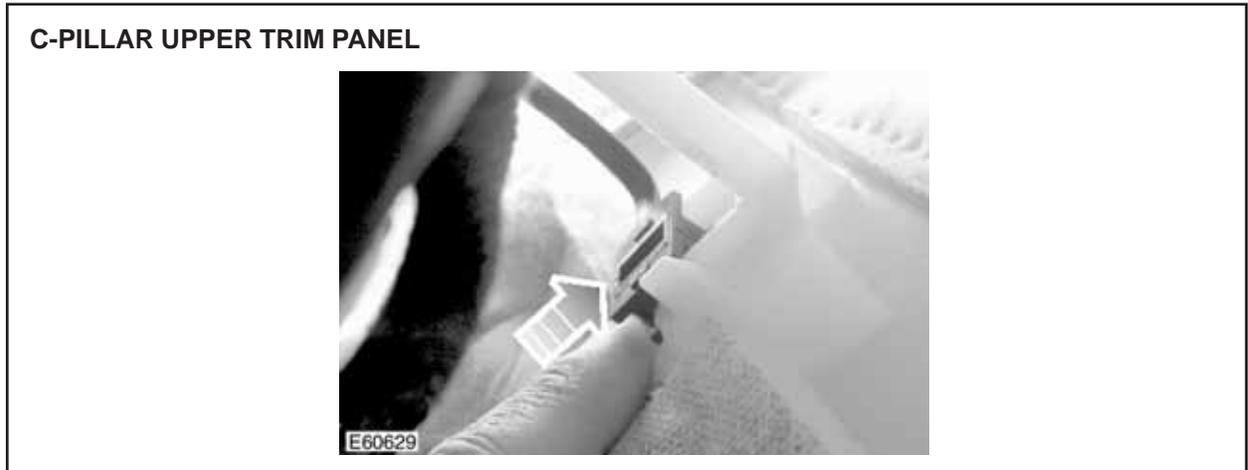
ILLUSTRATION 7

21. Install the retaining strap to the C-pillar upper trim panel, install and fully seat the upper C-pillar trim (Illustration 7).

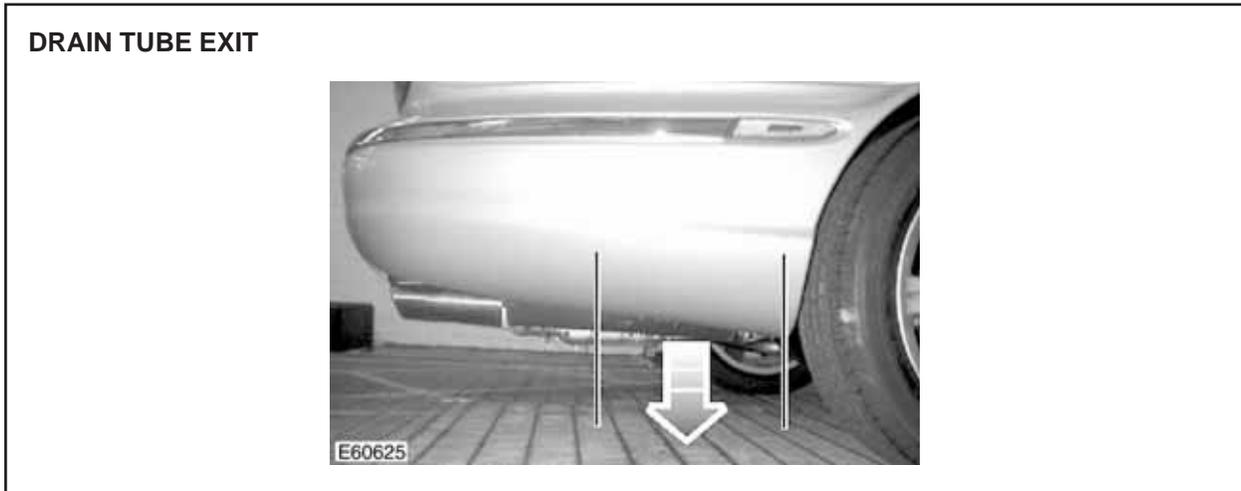
ILLUSTRATION 8

27. With assistance, look for water flowing onto the floor from the drain tubes behind the rear wheels (Illustration 8).
