Selector Lever (Gear Shift) Interlock –
Service Release Procedure

MODEL 2000 MY-ON
S-TYPE

VIN L00001-ON

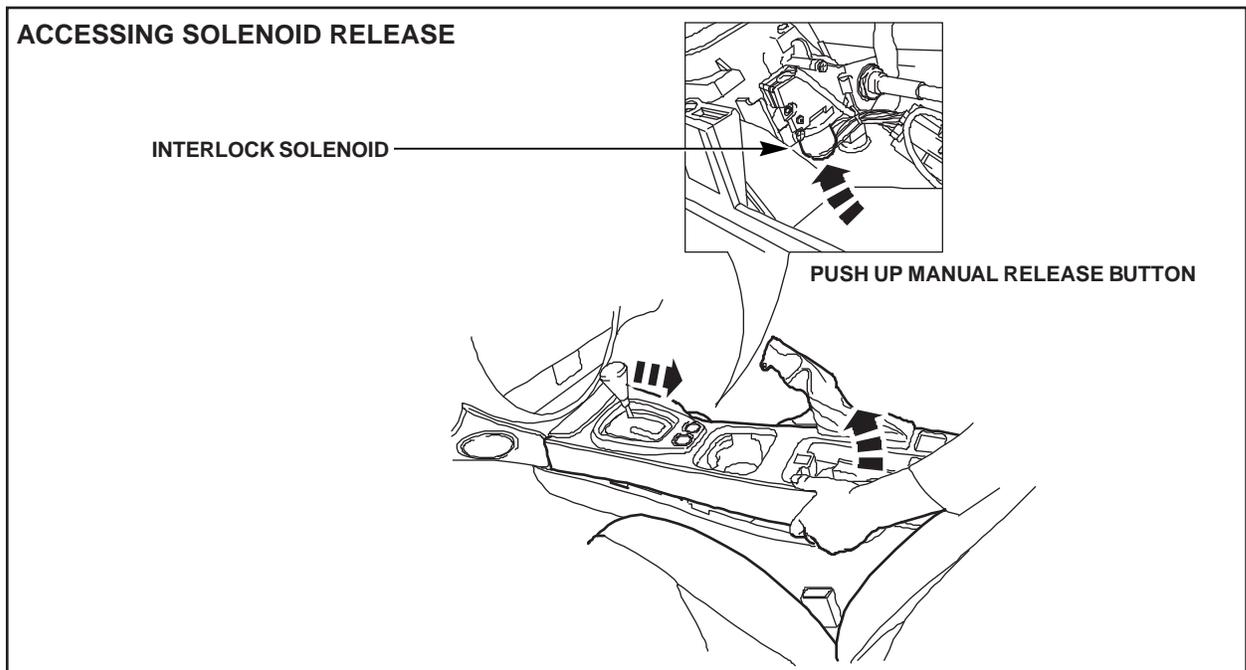
ILLUSTRATION 1

On 2000 MY-ON S-TYPE vehicles, the situation could occur that the gear selector lever remains locked in the 'P' position. While a discharged battery might be the primary cause of such a concern, other electrical malfunctions could also result in the same situation.

⚠ Caution: When raising/lowering the upper console, be careful not to damage the plastic trim around the selector opening.

4. Lift upper console from the rear to gain access to the selector lever interlock manual release (Illustration 1). Recover the 7 clips that secure the upper console to the lower console for reassembly.
5. Slide hand under the right side of console and raise manual release plunger (Illustration 1).
6. While holding plunger in raised position, move gear selector lever from 'P' to 'N'.
7. Reinstall the 7 clips onto the upper console and reassemble once the vehicle has been repaired.
