© D. Jensen 2006	REPLACEMENT OF XK8 CONVERTIBLE REAR WINDOW REGULATOR	V. 1.0 September 2006
Distribution: www.jag-lovers.com

While raising the top on my '01 XK8 convertible recently, I heard a loud "pop" from the right-rear seat area and saw that the rear quarter window was no longer operating. I could hear the drive motor cycle down and stop, and then cycle up and stop as I toggled the "Roof" switch. I also heard the sound of a cable flopping around.

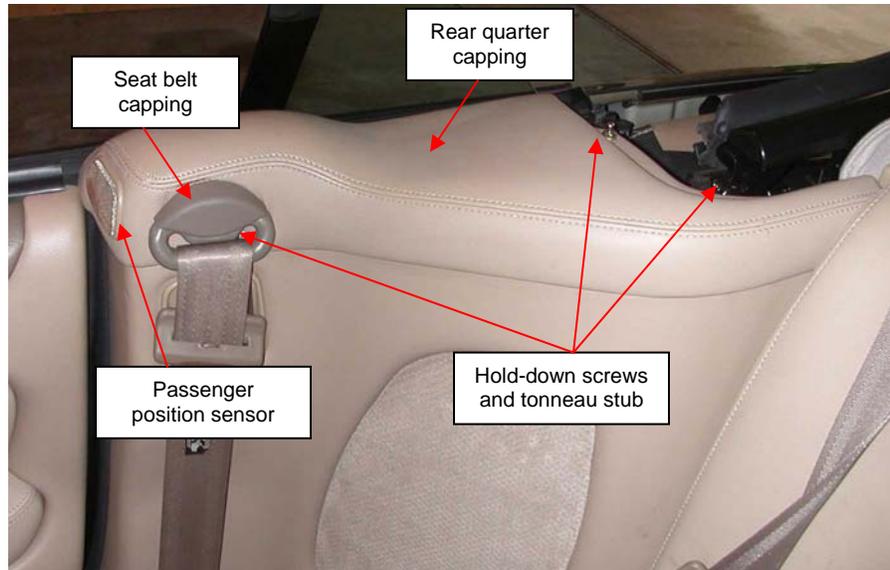
Fig. 2 Rear quarter capping

1. Lower the top and remove the rear quarter capping (see Fig. 2) (Sec. 76.40.33, Steps 1 - 4). The capping on my car is different than that found on earlier XK8s that do not have the integral passenger position sensor. First lift the seat-belt capping up and off the "B" post seat-belt bracket and unbolt the bracket with a T-50 star driver (see Fig. 3). Since the seat-belt bracket is held in place on the bolt by a rubber o-ring, the bracket will remain on the loosened bolt. There is, however, a wave washer that is not retained and will need to be set aside until reassembly. It is not necessary to loosen the lower end of the seat belt because the rear quarter trim panel does not need to be removed from the car.

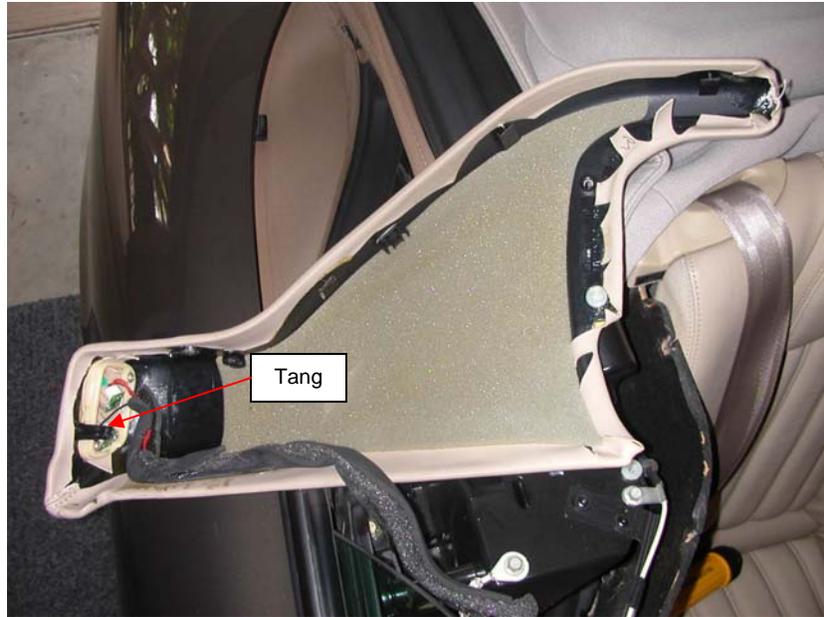
Fig. 4 Underside of rear quarter capping showing tang

2. Remove (a) the screw covered by the seat belt bracket, (b) the screw on the rear of capping, and (c) the 9-mm tonneau-cover fastener. Lift the capping off and disconnect the lead to the airbag passenger sensor, if your car has one. Note that there was a tang on my capping that keeps its front edge in place (see Fig. 4). I didn't realize this when I removed the capping, but fortunately I didn't break it off during removal. It was a bit tricky to reinstall the capping later due to the need to ensure the tang was positioned in its hole in the B post. Earlier XK8s have a screw where the passenger position sensor is located and thus may not have the tang.

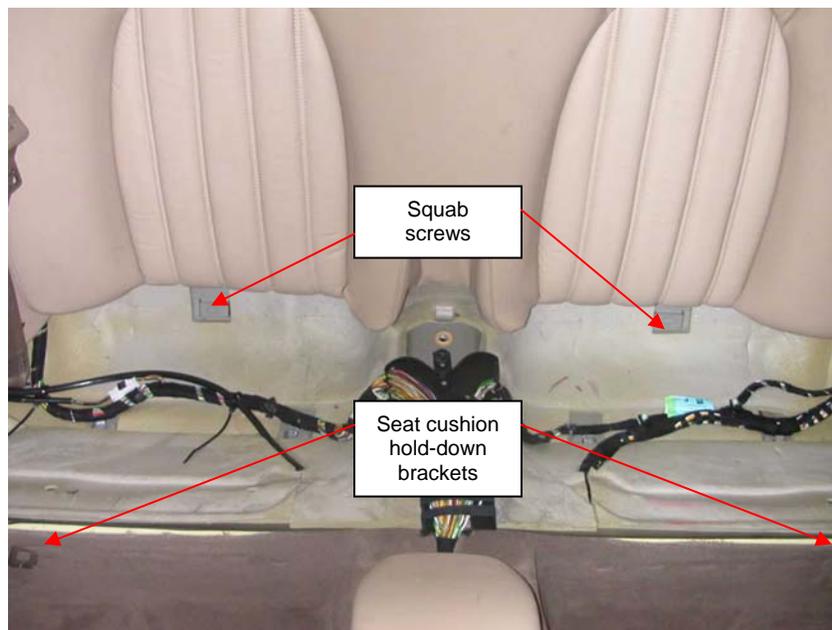
Fig. 5 Squab following removal of cushion

3. Remove the rear seat cushion (Sec. 76.70.37) and squab (seat back) (76.70.38). These steps are straight forward, as described in the manual. The seat is held in place by two 10-mm nuts with integral washers covered by plastic caps. The squab is held in place by two screws (see Fig. 5).

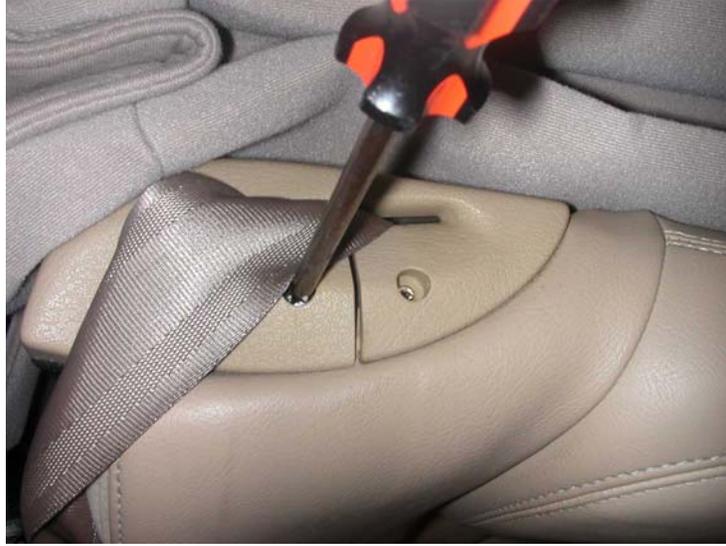
Fig. 6 Seat belt guide on seat back

4. Remove the seat belt guide at the top of the squab (Fig. 6) and lift the squab up and out (Fig. 7).

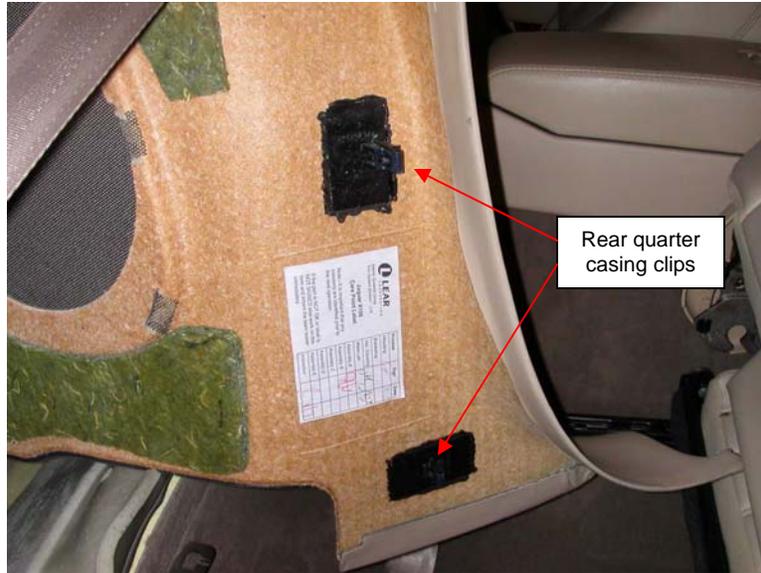
Fig. 8 Clips on front edge of rear quarter casing

5. Remove the rear quarter casing by freeing the two clips at the front edge (see Fig. 8) and pulling the casing forward along with the rear tang located in a positioning hole in the body. Position the casing toward the center of the car and out of the way (see Fig. 9). As noted earlier, it is not necessary to remove the seat belt that passes through it.

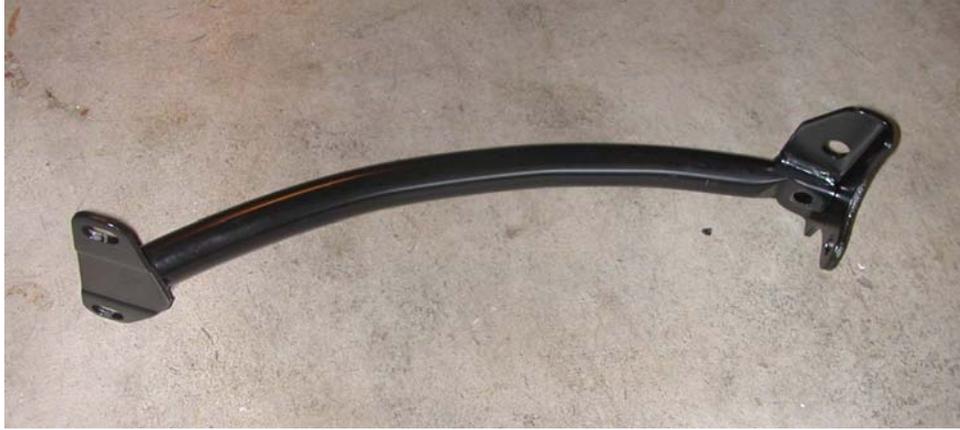
Fig. 10 Stiffening brace

6. Remove the four 13-mm bolts holding the stiffening brace (not introduced until the 1999 model year and not discussed in the instructions, but mentioned in "You & Your XK8" by Nigel Thorley, Haynes Publishing, 2006) in place (see Fig. 10). Note that the longer, anodized bolt threads into the hole that runs parallel to the squab back (not shown).

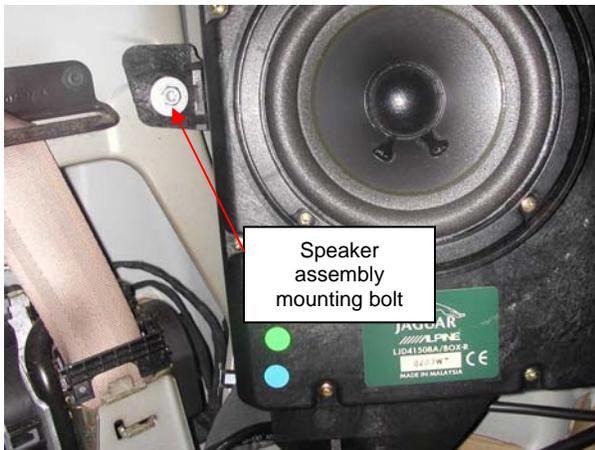
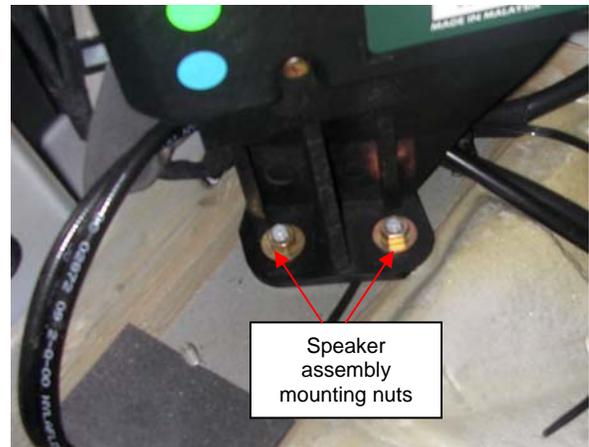
Figs. 11a and 11b Rear speaker mounting points

7. Disconnect the rear speaker harness multiplug (one vs. two described in the instructions) (Sec. 86.50.12). Remove the two 10-mm bolts and two 10-mm nuts holding the rear speaker assembly in place (see Figs. 11a and 11b) and remove the assembly.

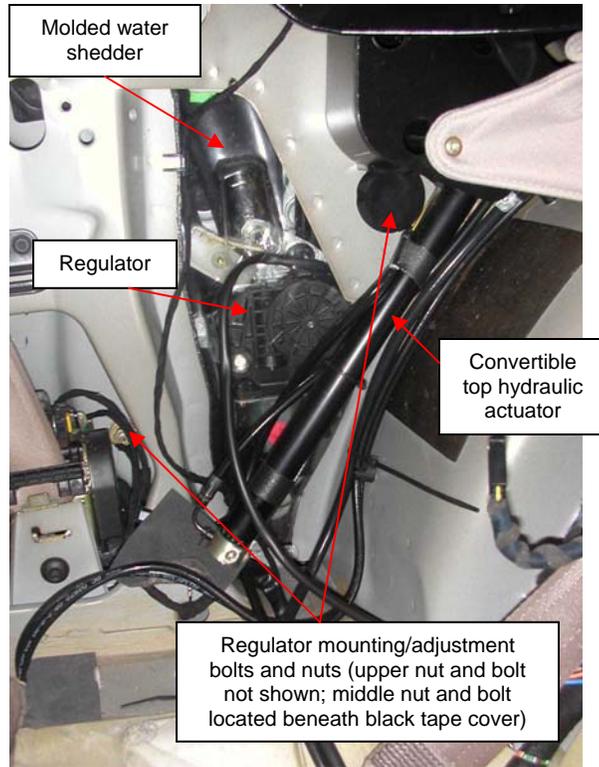
Fig. 12 Regulator as mounted

8. Note the location of (a) the window regulator, visible through the opening in the body and the clear, molded-plastic water shedder (see Fig. 12), and (b) the three adjusters/nuts. The lower nut/washer is held in place by silicone seal to ease installation (a big help). Remove the black, circular tape cover to gain access to the middle adjuster/nut. The top adjuster/nut is accessible as is. Note that the convertible top hydraulic actuator sits on a boss (not visible in photo) at about the midpoint of the actuator. It is not held in place by a fastener. Be sure to reposition it on the boss during reassembly.

14. Remove the upper and middle nuts holding the regulator in place and undo the lower nut (it will remain in place because the attached washer is held to the body by silicone sealer) (Sec. 86.25.11, Steps 12 and 13) (see Fig. 12 above). Route the feed link and multiplug connector through the water shedder. Once loose, push the regulator outward to free the adjustment bolts from their holes. As I inferred from the Jag instructions re removal of the top, I could not remove the window/regulator due to interference between the regulator motor and the convertible top bracket (see Fig. 19).

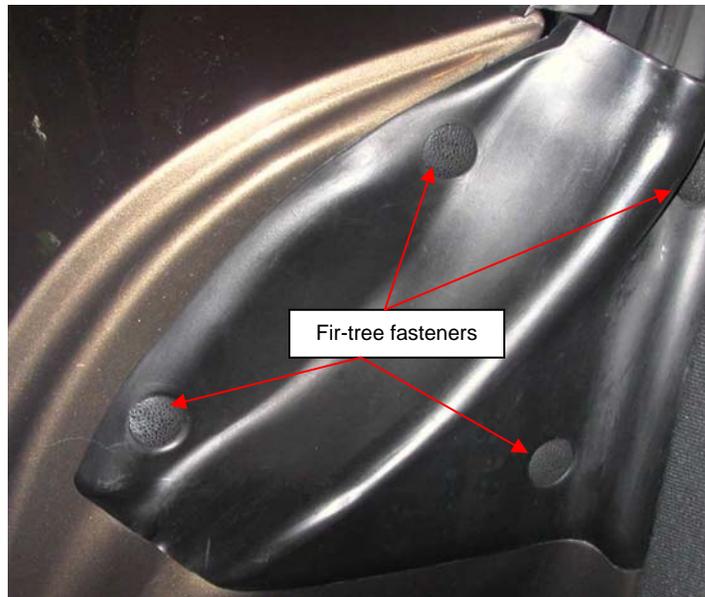
Fig. 13 Fir tree fasteners at front of window inner seal

9. Remove (a) the window inner seal by extracting the four “fir tree” fasteners on the front of the seal (Sec. 76.40.33) (see Fig. 13) using a flat-bladed screwdriver and (b) the screw securing the rear of the seal (see Fig. 14, which also shows the convertible top mounting bracket). Then remove the two 8-mm bolts holding the inner seal carrier in place (Sec. 86.25.11) (not shown).

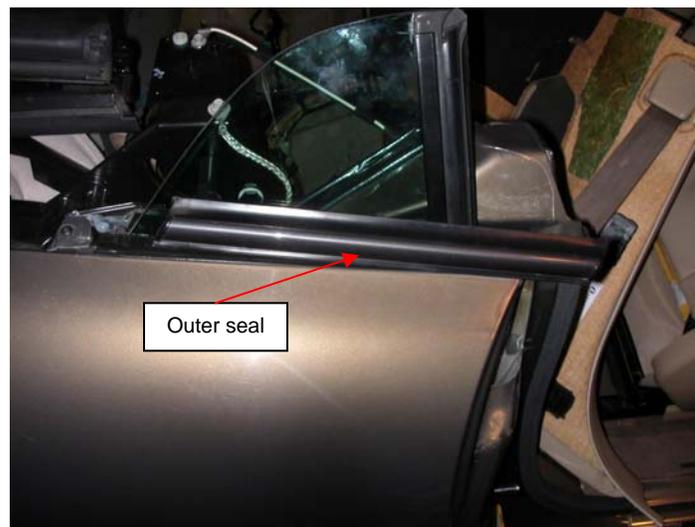
Fig. 15 Window outer seal

10. Remove the outer seal by pulling up (see Fig. 15). I did not need to use a knife as called for in the manual.

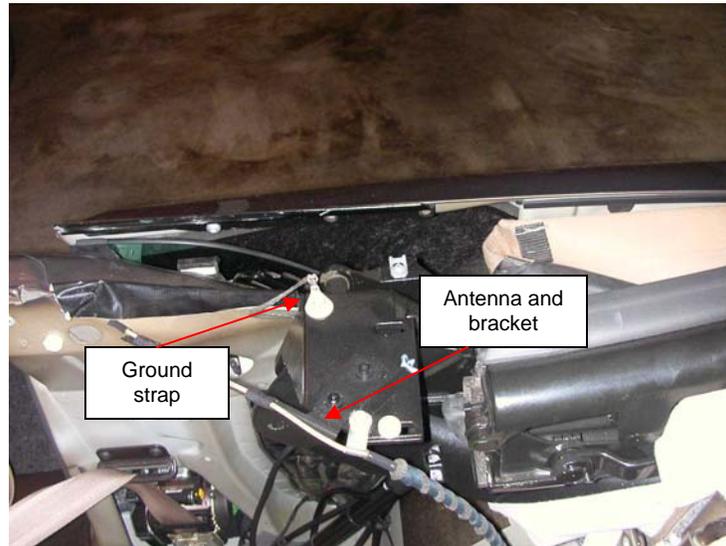
Fig. 16 Alarm antenna, support bracket and ground strap

12. Remove the alarm antenna and bracket (Sec. 76.86.15, Steps 12 and 13) (see Fig. 16). While not strictly necessary, these both appear to be fragile items that are best moved out of the way. I also removed the ground strap as well.

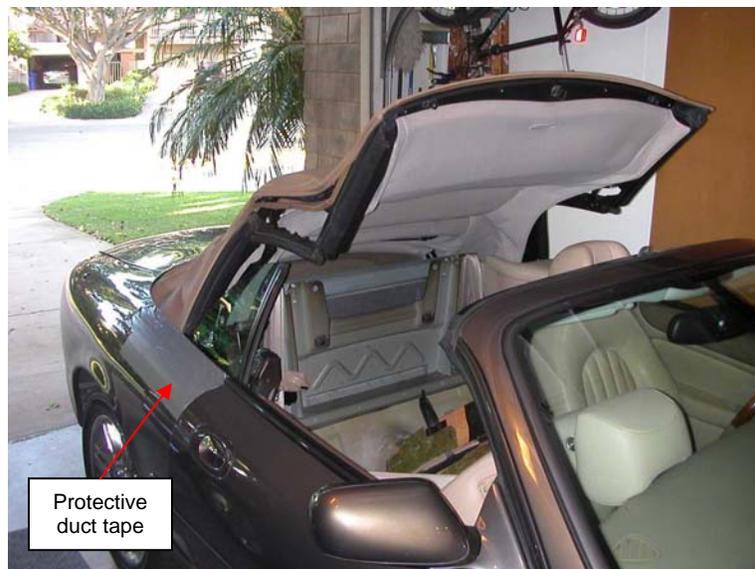
13. Apply several layers of duct tape or similar protective material to the fender surface to prevent possible scratches (see Fig. 17). Disconnect the battery negative ground strap, loosen the top of the trunk right-hand liner, and turn the convertible top hydraulic pump valve fully counter clockwise (Sec. 76.86.15, Steps 15 and 16). Manually raise the top to a partially closed position. This provides improved access to the convertible top mounting-bracket cover-plate screws, bracket (see Fig. 14 above), and bracket mounting bolts (see Fig. 18).

Fig. 17 Roof partially closed to allow access to top bracket cover and mounting bolts
