**Technical Guide**

**XJS HOOD  
SEALING  
TECHNIQUES**

# XJS HOOD SEALING TECHNIQUES

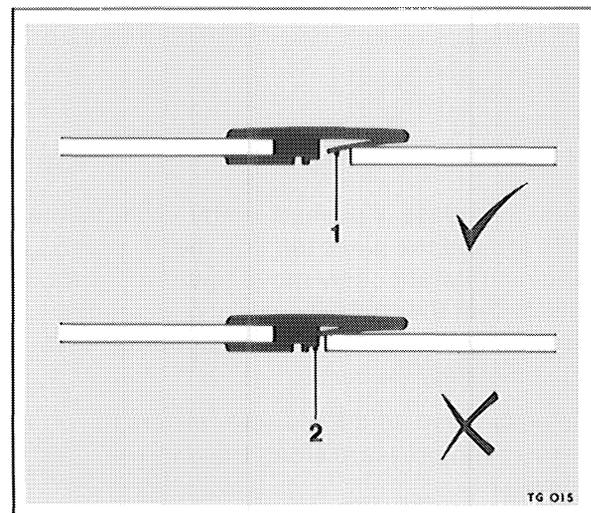
Fig 9.2

Aim also, to finish with sufficient pressure exerted on the front, centre and rear hood seals, the 'A' post seal and the seal which runs between the rear edge of the door glass and the 'D' light. The 'flock' sprayed section of this seal (1 Fig. 9.2) must be lightly and evenly compressed along its full length. The seal must not be compressed so far that it touches the rubber inner lip (2 Fig. 9.2). The lip is not a seal, and if fouled will permit water to track across and cause a leak.
