Sedan Range

08.2-01

TECHNICAL BULLETIN

Transmission MIL Illumination – Revised EPROM – Replacement Procedure

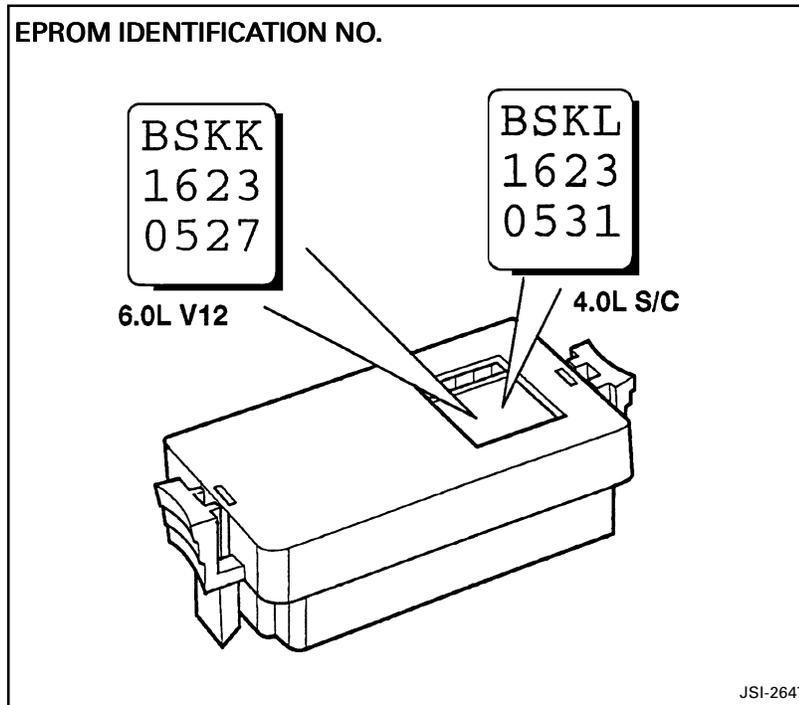
ILLUSTRATION 4

6. The EPROM has a retaining latch at each end. These latches must be pressed in while removing the EPROM from the socket. Press the latches inward and ease each latch free of the socket. Then, carefully remove the EPROM module from the circuit board.
7. Align the vertical rib (Illustration 3), indicated by an arrow, on the replacement EPROM with the rib on the socket to ensure correct alignment.

Install the replacement EPROM module in the board socket while holding the board through the opening in the end support. Press the EPROM down into the socket until the latches engage.
