S204-S516

TECHNICAL BULLETIN

Spare Tire Speed Restriction Label –
Lack of Adhesion –
Service Action S516

MODEL 2005 MY
S-TYPE

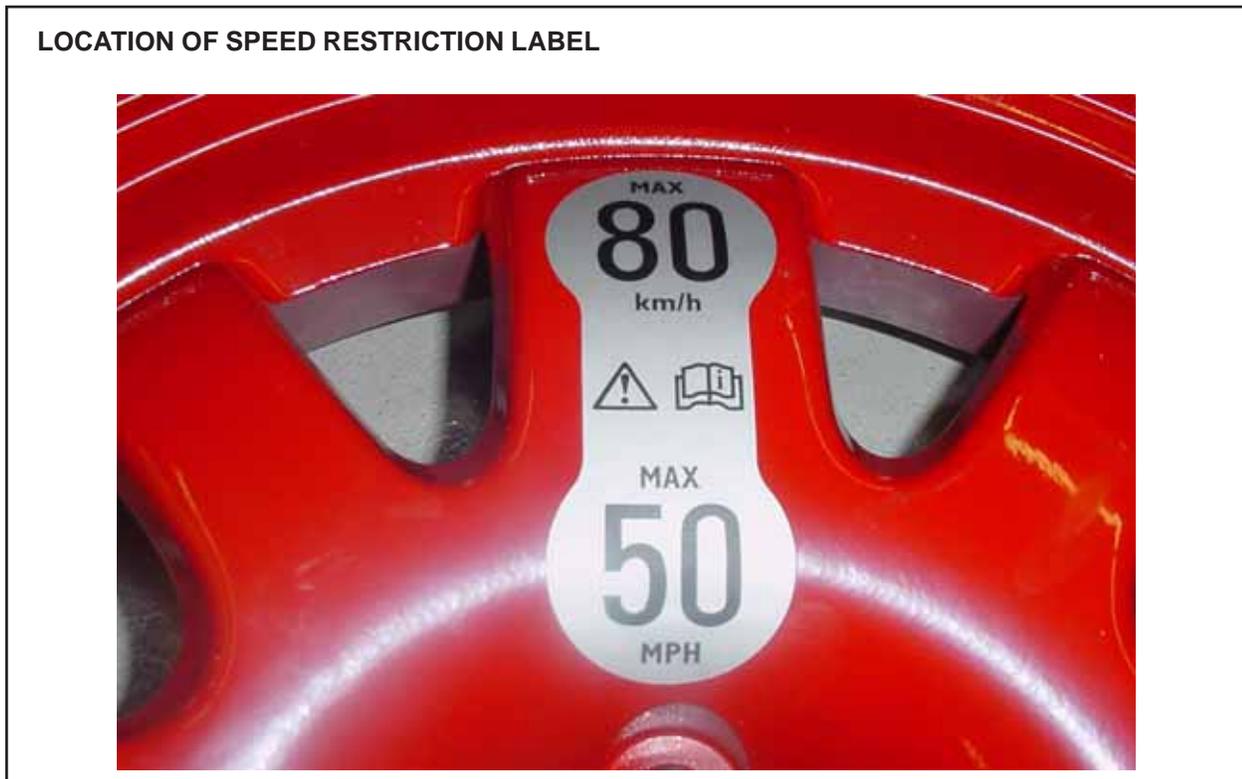
ILLUSTRATION 1

A concern has been identified on a number of 2005 MY S-TYPE vehicles that are listed in this bulletin. On vehicles supplied with space saver spare wheels, poor adhesion of the speed restriction label could result in the label coming loose from the space saver spare wheel.

4. Remove the tee bolt securing the space saver spare wheel.
5. Remove the space saver spare wheel and place aside.
6. Remove the old speed restriction label from space saver spare wheel.
7. Clean the area of space saver spare wheel before installing the new label.
8. Install the new speed restriction label on the front face of the wheel (Illustration 1).
