15-26

In Car Entertainment – Radio Inoperative –  
Transit Protection

MODEL 1995 MY  
Sedan Range

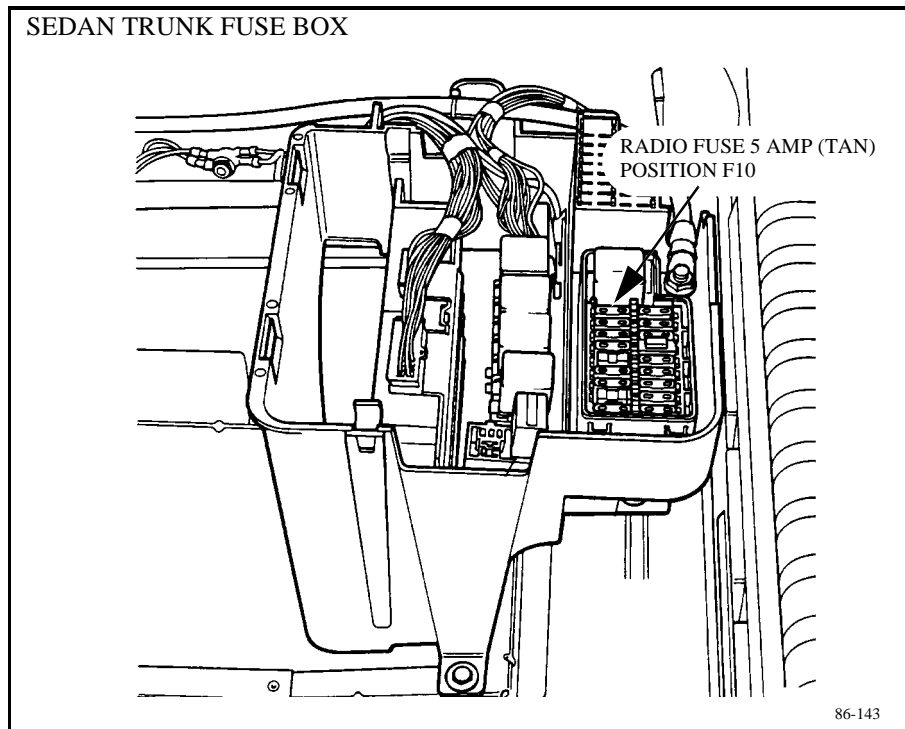
ILLUSTRATION 1

The radio is inoperative on 1995 MY Sedan Range vehicles on delivery to dealers. The radio fuse is removed at the PDI center to protect the antenna during transit.

1. Remove the 5 AMP (tan) fuse from the trunk spare fuse socket.
2. Install the 5 AMP (tan) fuse in position F10 of the fuse box (Illustration 1).
